# FACILITY CONDITION ASSESSMENT

FACILITY CONDITION ASSESSMENT  
OF

GOLDEN VIEW ELEMENTARY SCHOOL  
17251 GOLDEN VIEW LANE  
HUNTINGTON BEACH, CALIFORNIA 92647

June 1, 2016

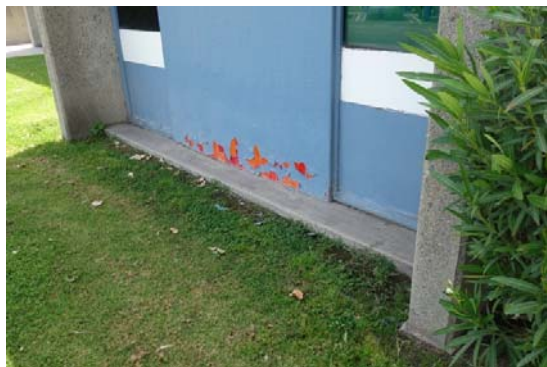
Photo #11: Exterior Wood Panel Damage

The substrate here is actually ceramic tile, and the paint is peeling away.

6.4	Exterior walls between Tilt Wall Sections	436339	Exterior Wall, Wood Clapboard, 1-2 Stories, Replace	1000	SF	\$27.03	\$27,026	<b>\$27,026</b>
7.1	Rooftop	436082	Package Unit, 21 to 25 Ton, Replace	4	EA	\$44,377.70	\$177,511	<b>\$177,511</b>

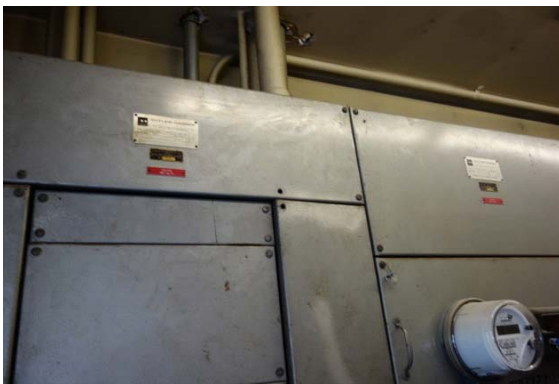
Photo #17: Main Switchgear

- Replacement of rooftop package units
- DDC HVAC balancing and control system upgrade
- Modernization of electrical system, replace original 1970 Switch Gear Enclosures , branch reportedly upgraded in 2002/4
- Significant ADA accessibility upgrades – based on previous ADA study and upgrades scheduled for Aug 2016
- Repair Parking Lot

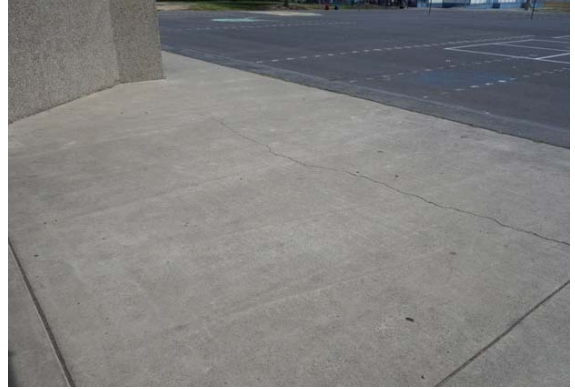
- The asphalt pavement exhibits isolated areas of failure and deterioration, such as alligator cracking, and localized depressions
- The concrete sidewalks have isolated areas of vertically-displaced concrete due to settlement.

Photo #20: Concrete Sidewalk

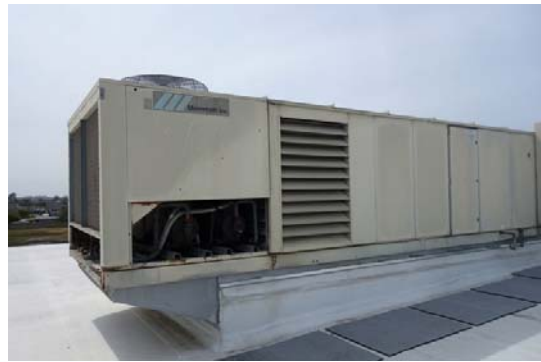
Photo #34: 20 Ton Mammoth Heating and AC Package Unit

7.1	Rooftop	436311	Package Unit, 16 to 20 Ton, Replace	1	EA	\$36,777.37	\$36,777	<b>\$36,777</b>
9	Portable Classroom on West Side of Building	436362	Roof, Asphalt Shingle, Replace	1100	SF	\$3.42	\$3,763	<b>\$3,763</b>
9	Portable Classrooms	436361	Heat Pump, 3.5 to 5 Ton, Replace	4	EA	\$8,928.22	\$35,713	<b>\$35,713</b>
<b>Immediate Repairs Total</b>								<b>\$294,228</b>

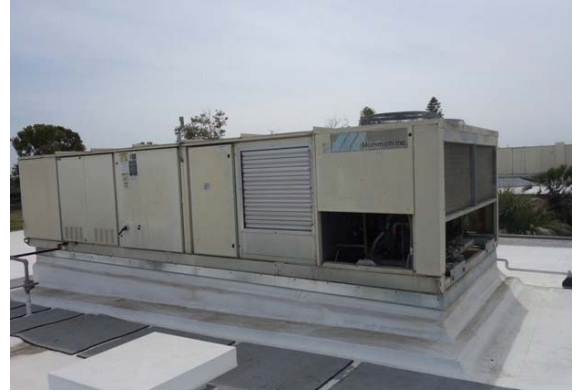
Photo #38: 25 Ton Mammoth Heating and AC Package Unit

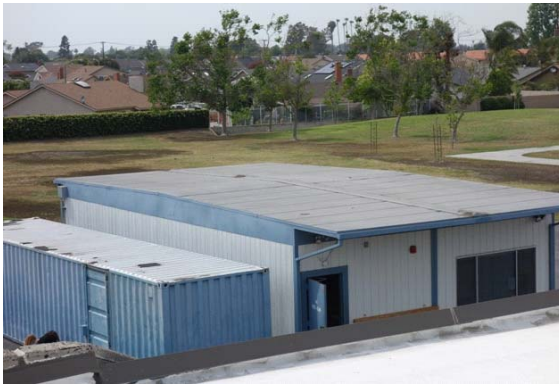
Photo #39: Portable with Asphalt Roof

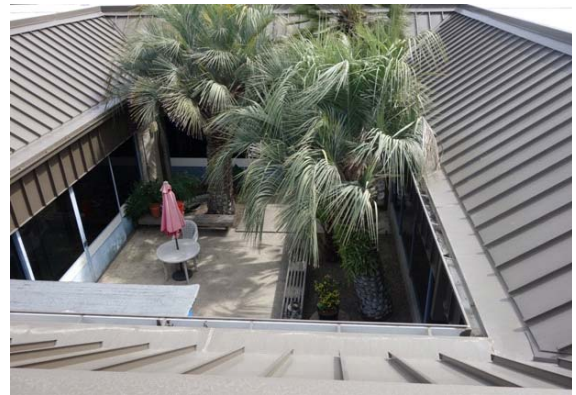
Photo #40: Soffit and Gutter View

6.3	Center of building	436307	Gutters & Downspouts, Aluminum w/ Fittings, Replace	175	LF	\$8.37	\$1,465	<b>\$1,465</b>
6.4	Throughout property	436334	Exterior Wall, Joint Caulking 0" to 1/2", 1-2 Stories, Replace	1000	LF	\$2.82	\$2,820	<b>\$2,820</b>

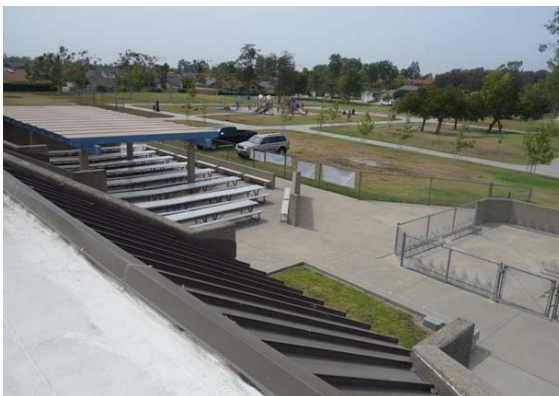
Photo #41: North View and Chain Link Fence

Report Section	Location Description	ID	Cost Description	Quantity	Unit	Unit Cost	Subtotal	Deficiency Repair Estimate *
5.5	Play area separation	436359	Chain Link Fence, 3' to 4' High (per LF), Replace	300	LF	\$30.51	\$9,154	<b>\$9,154</b>

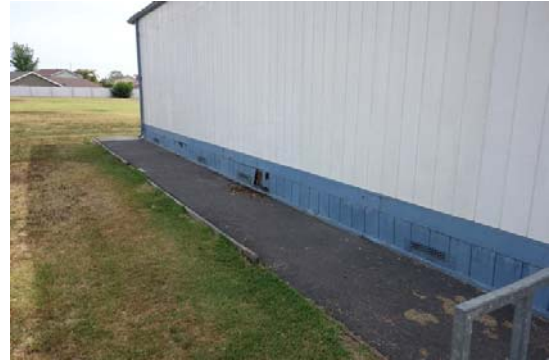
Photo #50: Portable Wooden Panel Damage
