FACILITY CONDITION ASSESSMENT

FACILITY CONDITION ASSESSMENT
OF
HOPE VIEW ELEMENTARY SCHOOL
17622 FLINSTONE LANE
HUNTINGTON BEACH, CALIFORNIA 92647

May 23, 2016

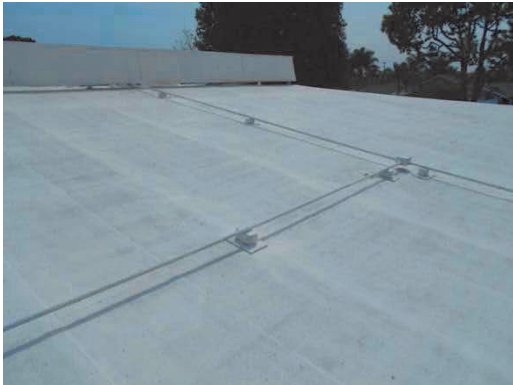
PHOTO #27: MAIN BUILDING BUILT-UP ROOF

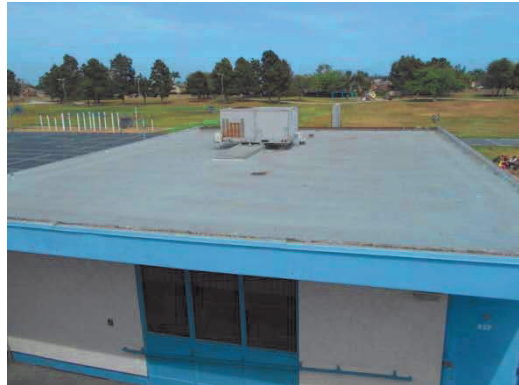
PHOTO #28: PORTABLE BUILDING BUILT-UP ROOF

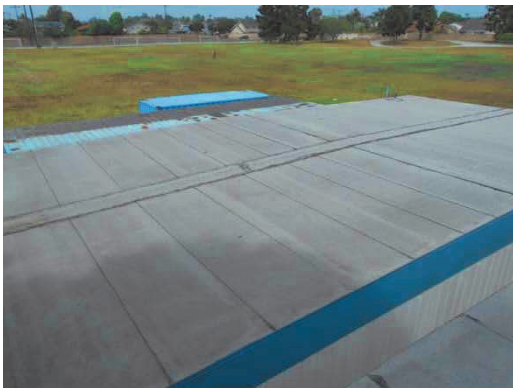
PHOTO #29: PORTABLE BUILDING BUILT-UP ROOF

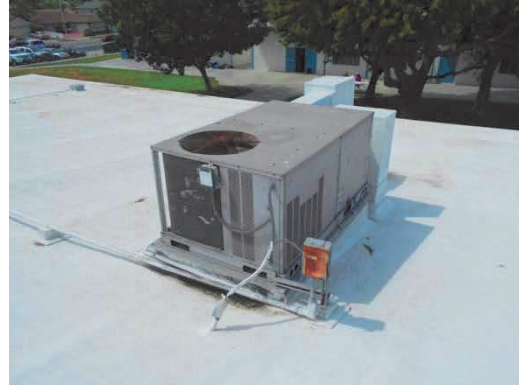
PHOTO #38: ROOFTOP HEAT PUMP

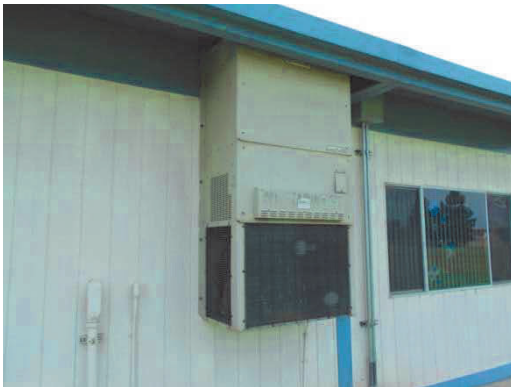
PHOTO #39: WALL MOUNTED HEAT PUMP
