FACILITY CONDITION ASSESSMENT

FACILITY CONDITION ASSESSMENT
OF
LAKE VIEW
17451 ZEIDER LANE
HUNTINGTON BEACH, CALIFORNIA 92647

119317.16R000-006.017

June 2, 2016

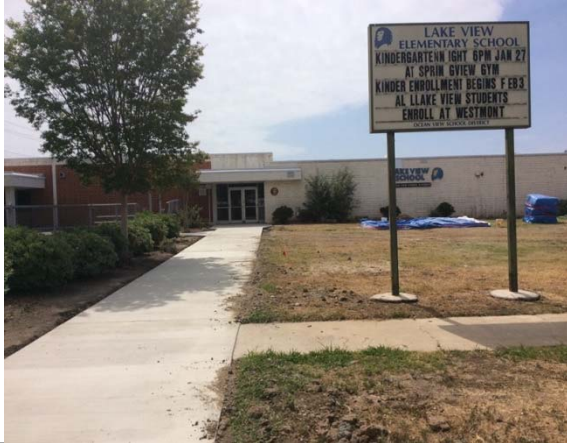
Photo #1: Front elevation of Main Building

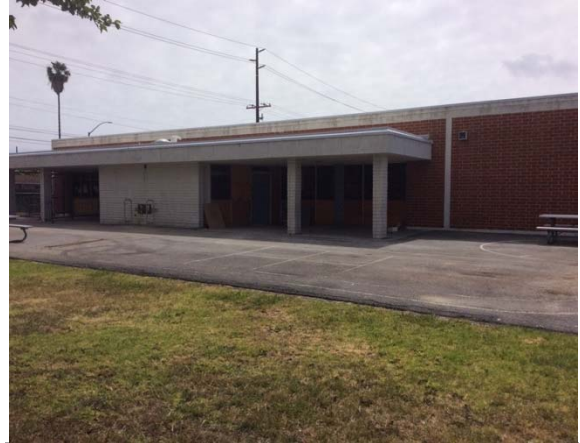
Photo #2: Side elevation of Main Building

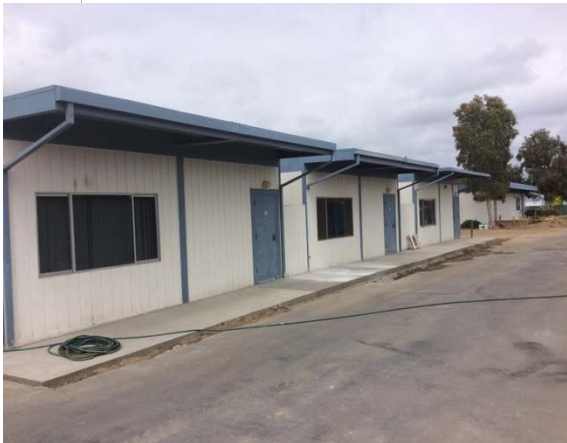
Photo #3: Front view of portables

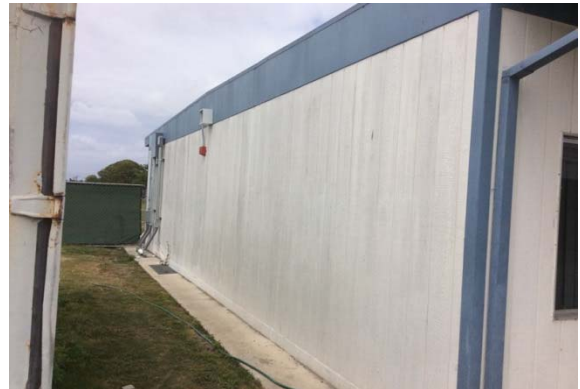
Photo #4: Side view of a portable building

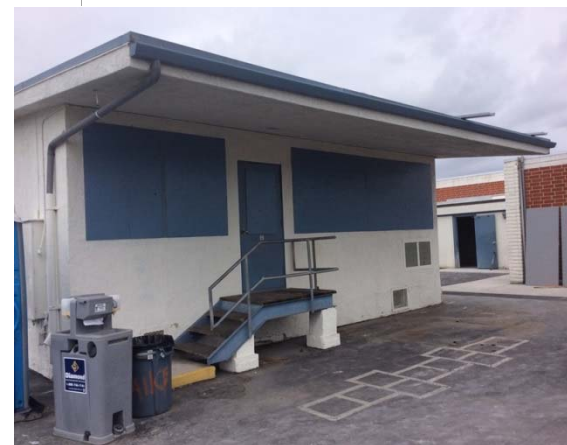
Photo #5: Front view of Building 19

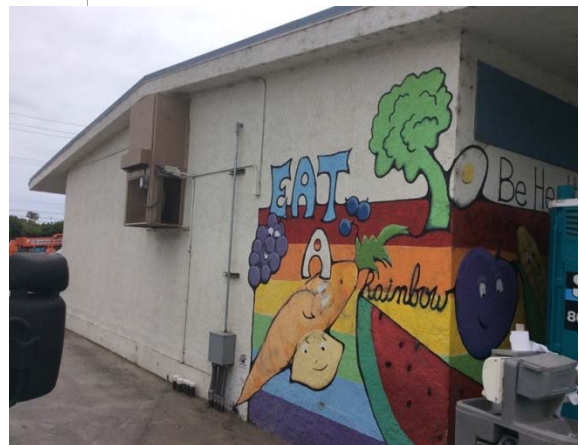
Photo #6: Side view of Building 19

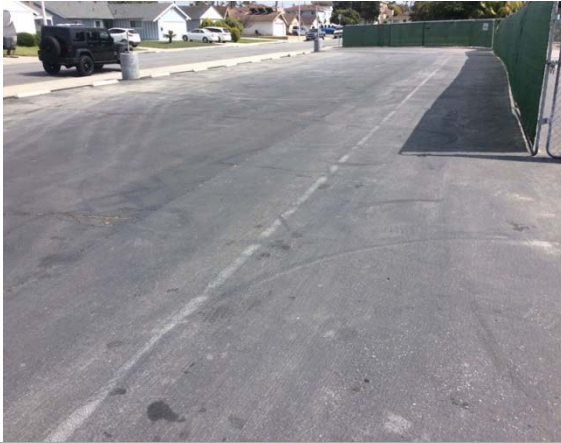
Photo #7: Parking lot

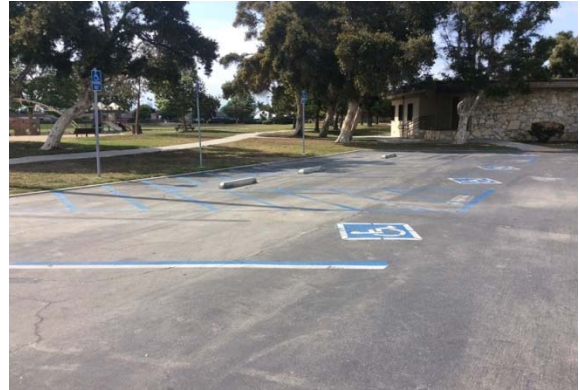
Photo #8: Parking lot with ADA spaces

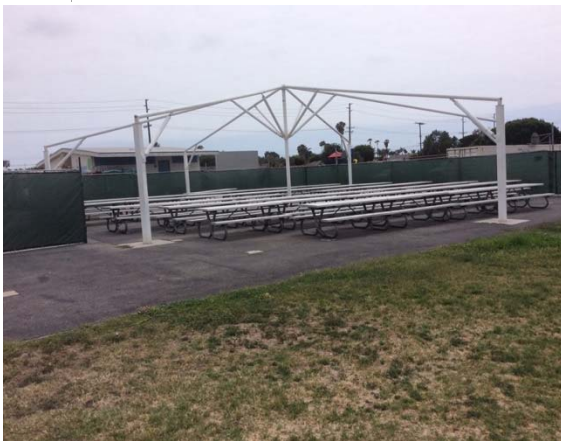
Photo #9: Lunch shelter

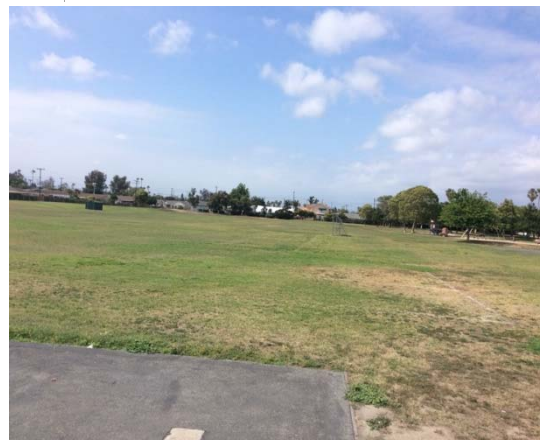
Photo #10: Playing field

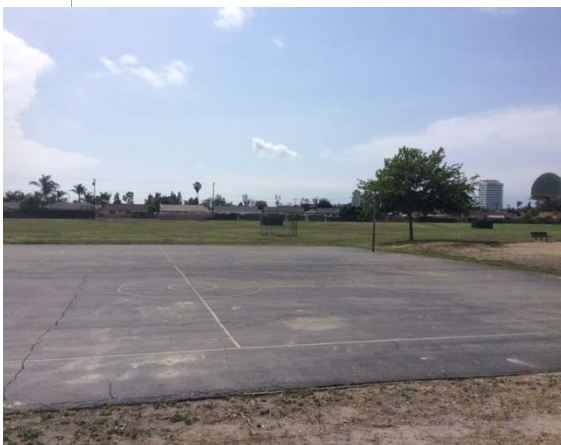
Photo #11: Basketball court

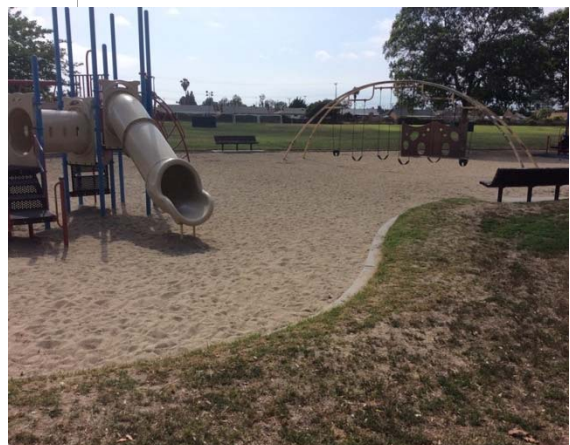
Photo #12: Play area

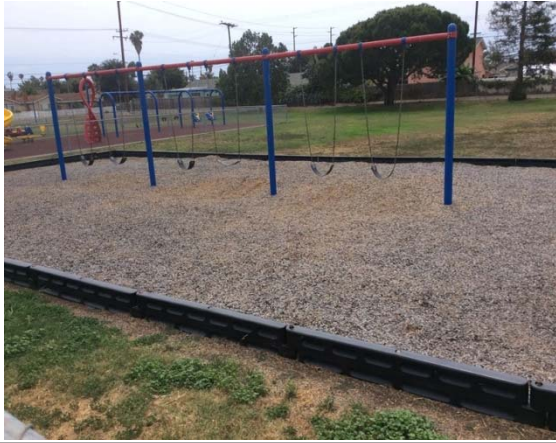
Photo #13: Play area

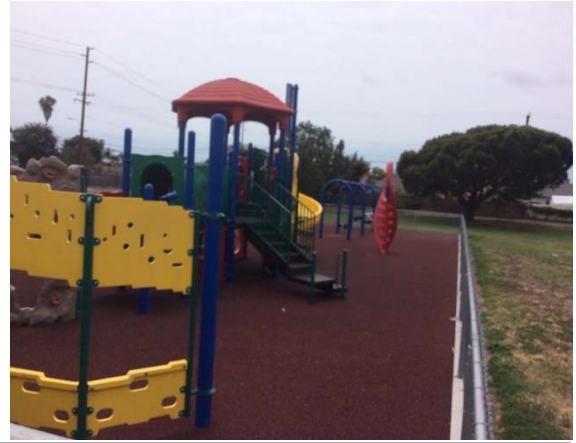
Photo #14: Play area

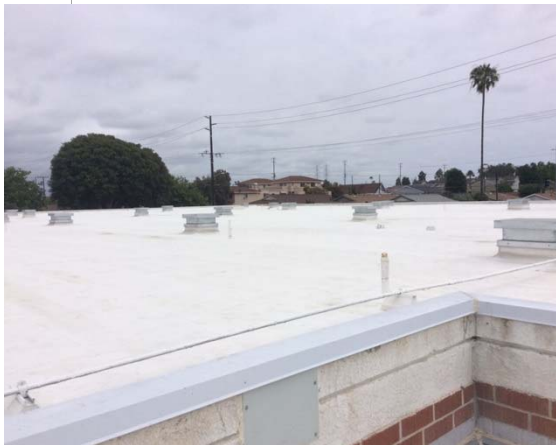
Photo #15: Overview of roofing at Main Building

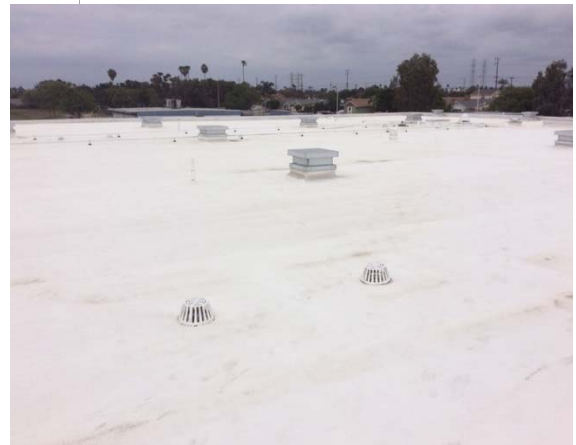
Photo #16: Overview of roofing at Main Building

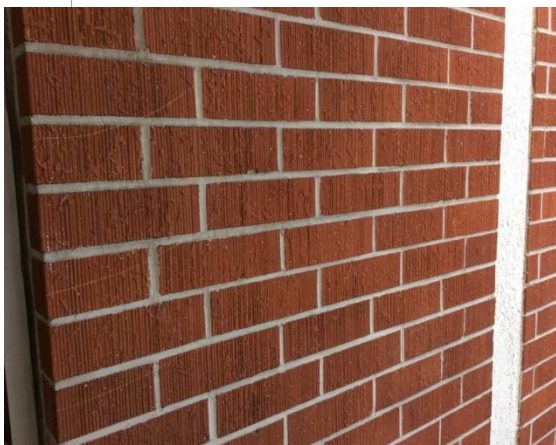
Photo #17: Exterior CMU wall at Main Building

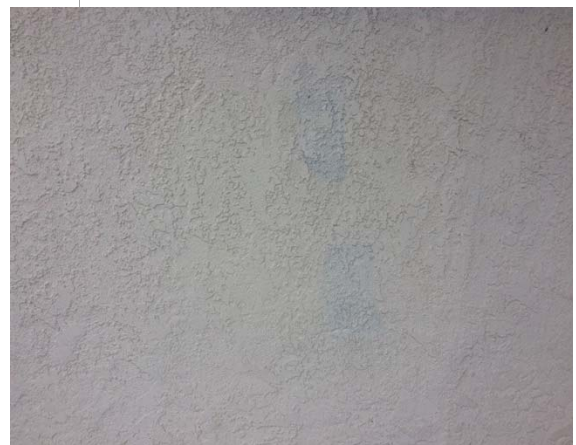
Photo #18: Stucco wall at Building 19

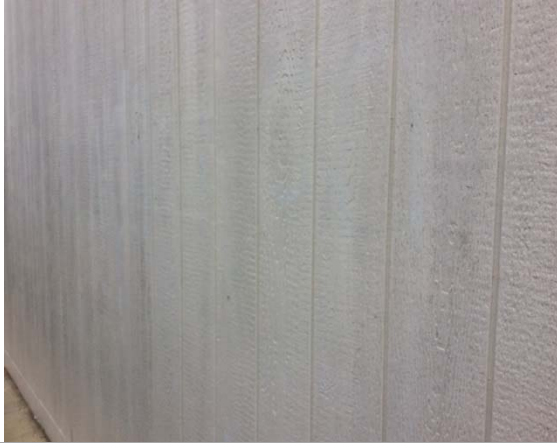
Photo #19: Wood siding at portables

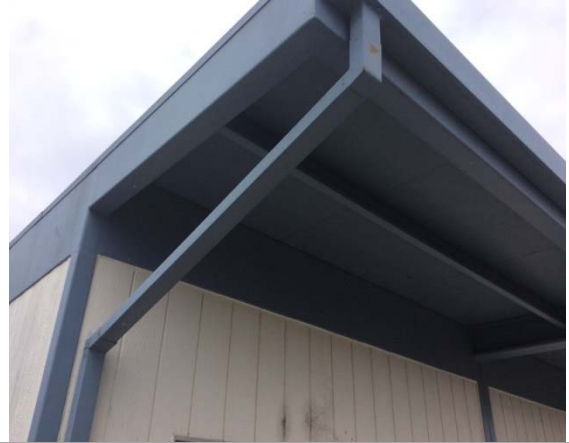
Photo #20: Soffit, gutter and downspout at portables

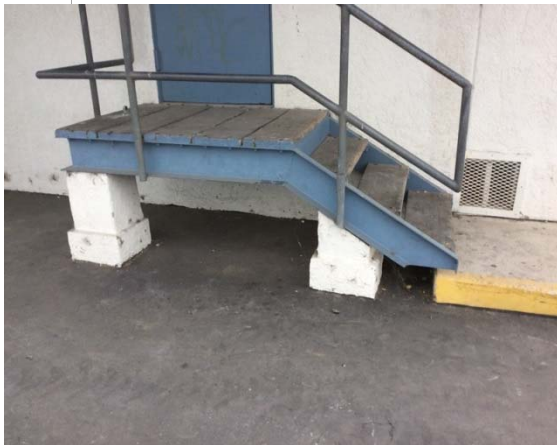
Photo #21: Steel framed with wood treads stairs

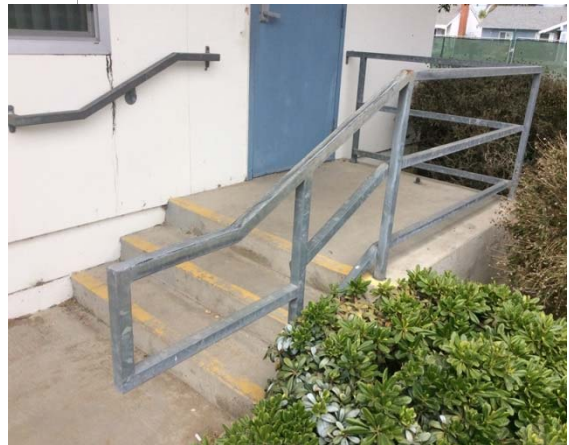
Photo #22: Concrete stairs with metal rails

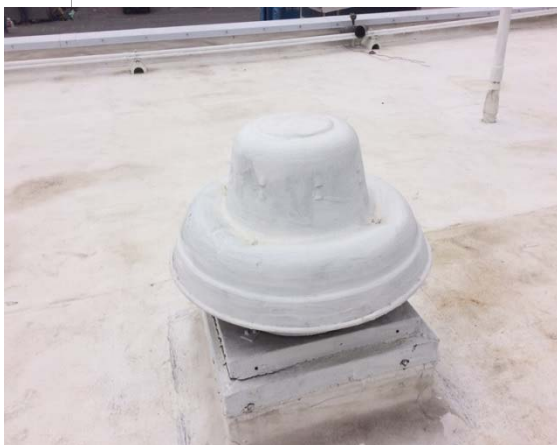
Photo #23: Exhaust fan

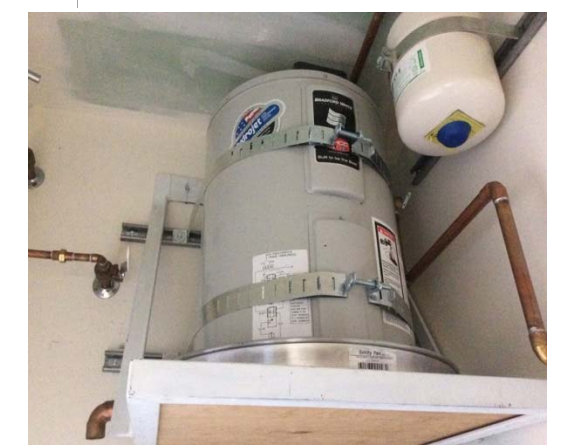
Photo #24: Electric water heater

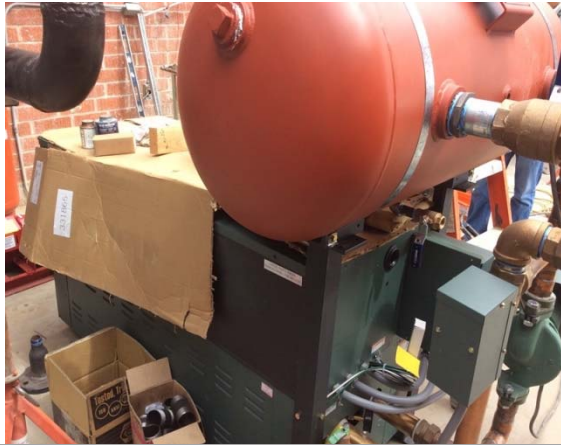
Photo #25: Boiler with expansion tank

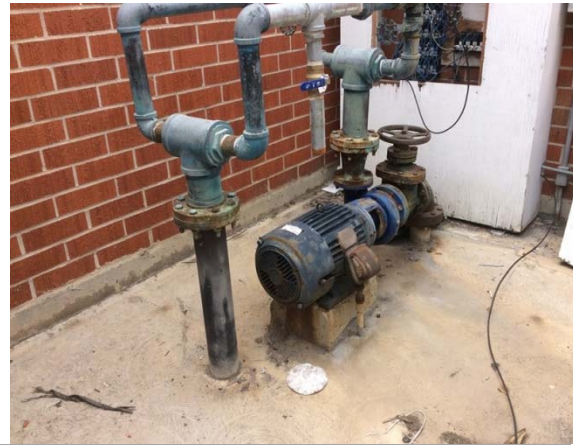
Photo #26: Irrigation pump

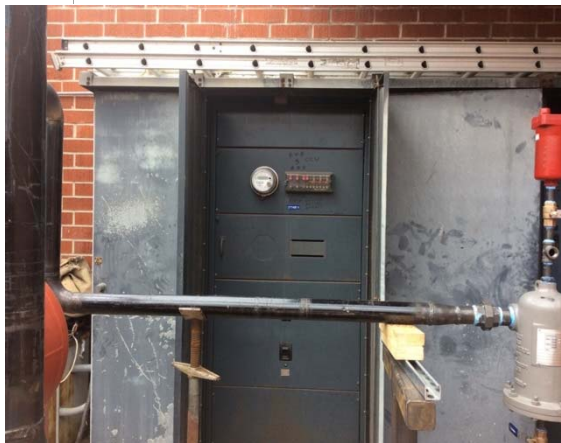
Photo #27: Main switchgear

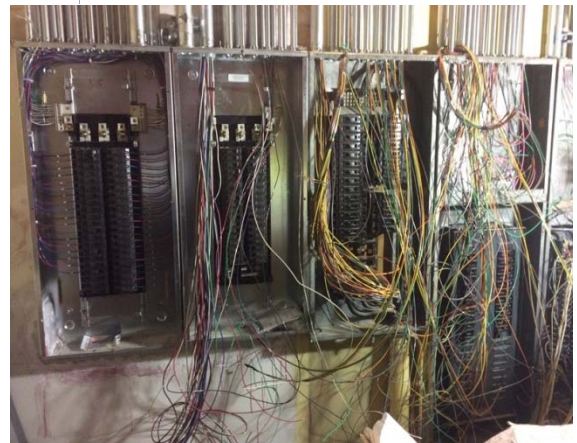
Photo #28: Newly installed panel boxes

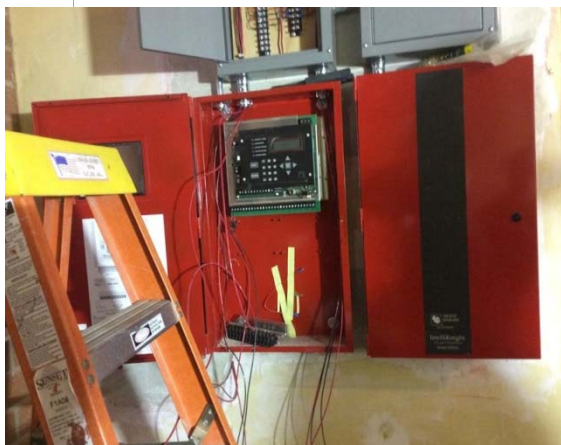
Photo #29: Fire alarm control panel

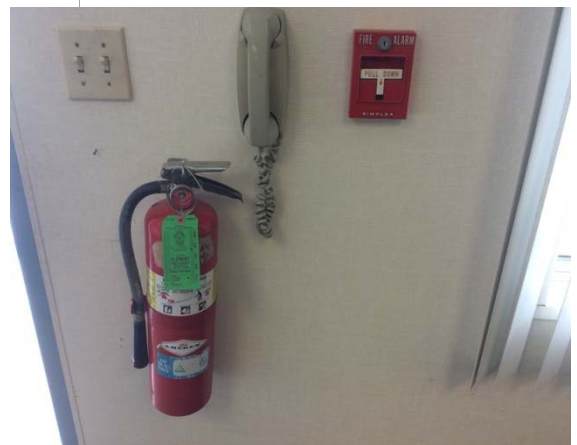
Photo #30: Fire extinguisher and pull station

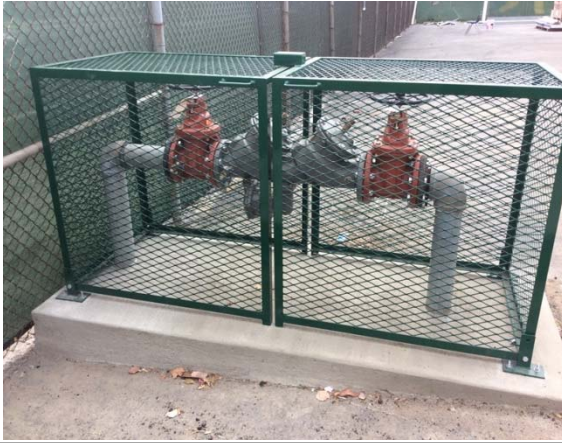
Photo #31: Backflow preventer

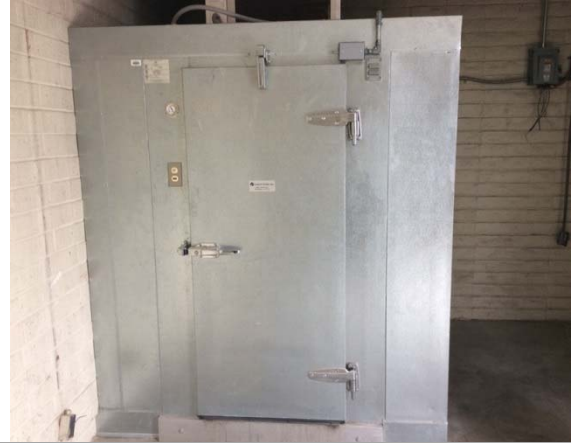
Photo #32: Walk-in freezer

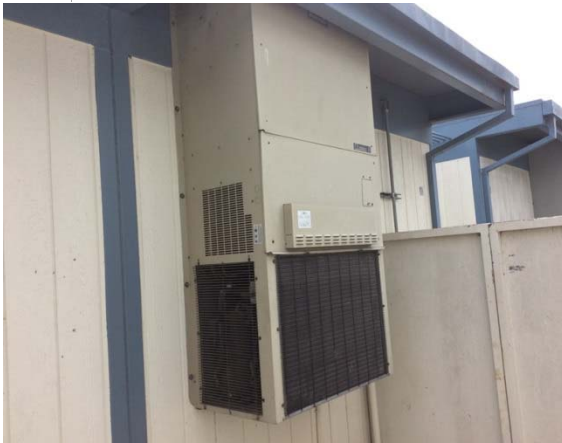
Photo #33: Wall-mounted package heat pump

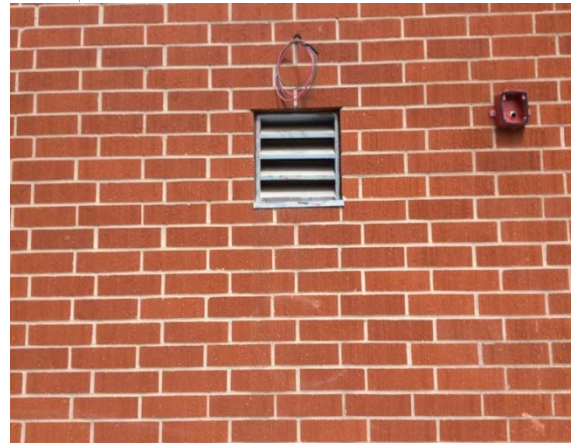
Photo #34: Wall ventilation

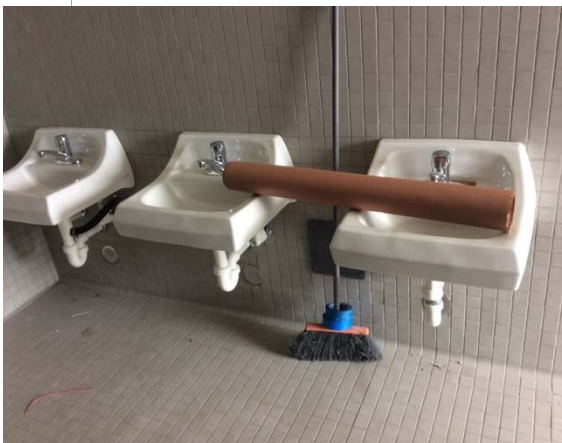
Photo #35: Lavatories

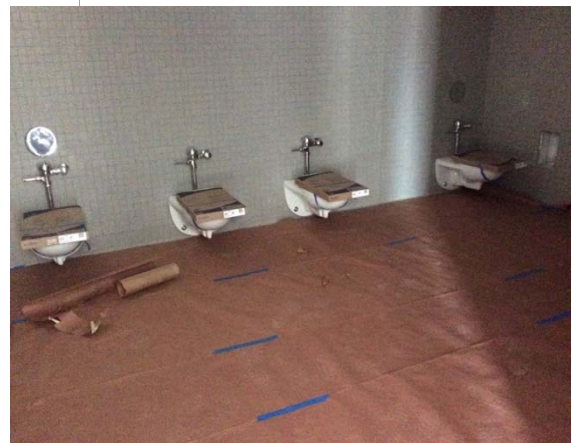
Photo #36: Water closets

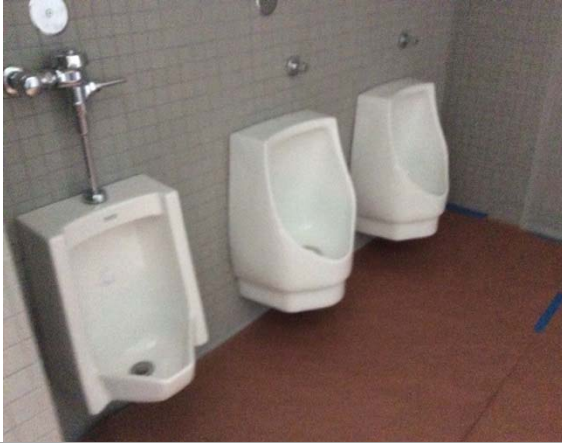
Photo #37: Urinals

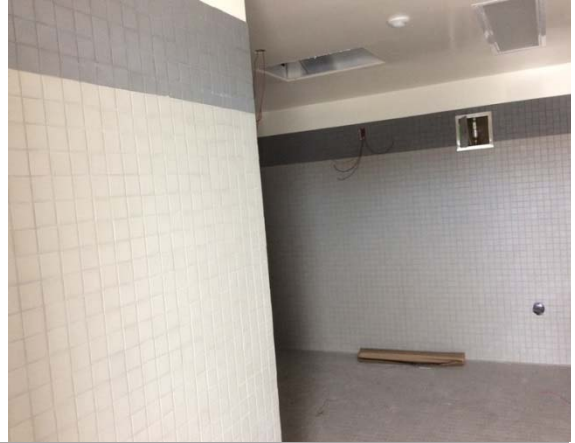
Photo #38: Ceramic wall tiles in bathroom

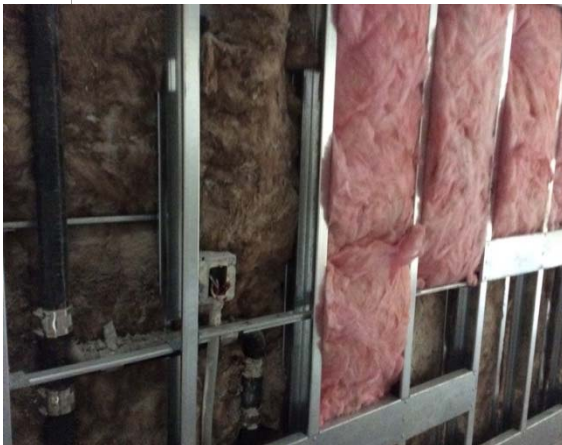
Photo #39: Fiberglass insulation

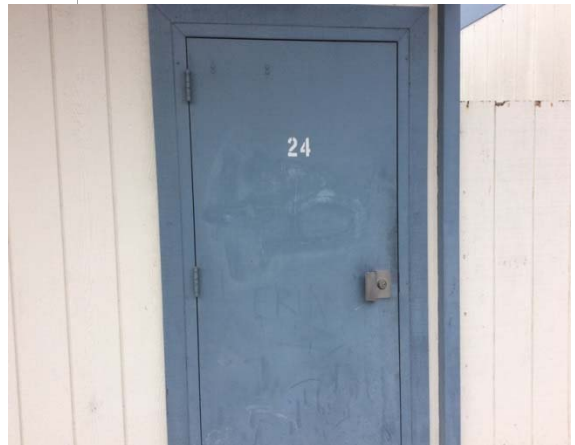
Photo #40: Single metal exterior door

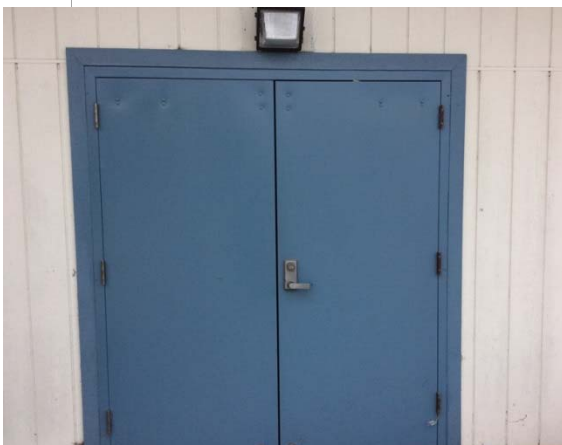
Photo #41: Double metal exterior door

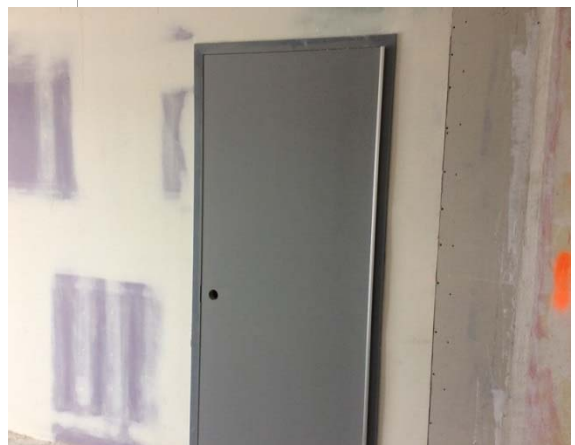
Photo #42: Metal interior door

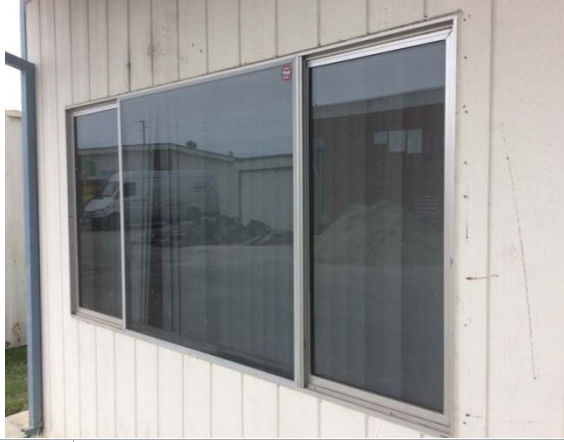
Photo #43: Aluminum-framed sliding window

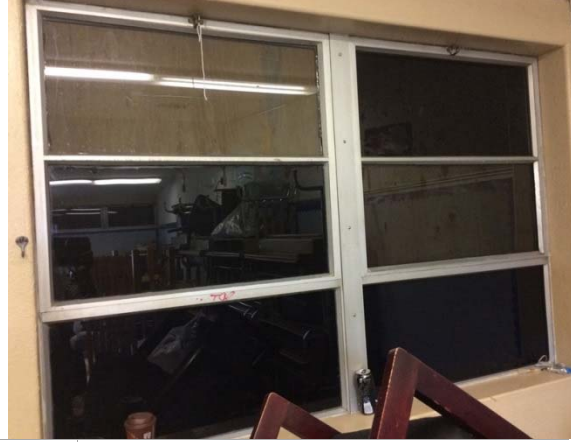
Photo #44: Aluminum-framed hopper window
