# FACILITY CONDITION ASSESSMENT

FACILITY CONDITION ASSESSMENT  
OF  
MARINE VIEW MIDDLE  
5682 TILBURG DRIVE  
HUNTINGTON BEACH, CALIFORNIA 92649

119317.16R000-007.017

June 7, 2016

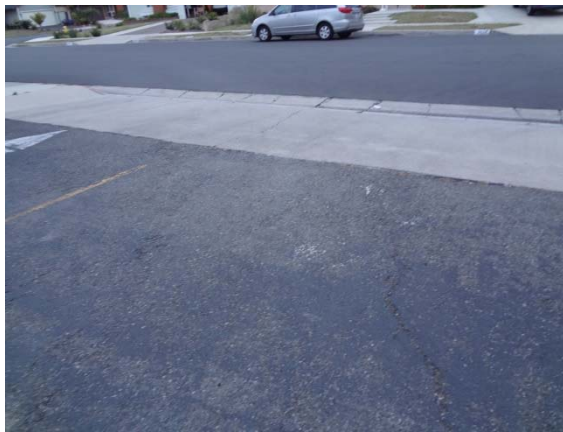
Photo #15: General Cracking Main Lot

- No significant actions are identified at the present time. On-going periodic maintenance is highly recommended. Future lifecycle replacements of the components listed above will be required.
- The asphalt pavement exhibits isolated areas of failure and deterioration, such as cracking in the main parking lot. The most severely damaged areas of paving must be cut and patched in order to maintain the integrity of the overall pavement system. Complete overlay of the entire lot is also recommended.

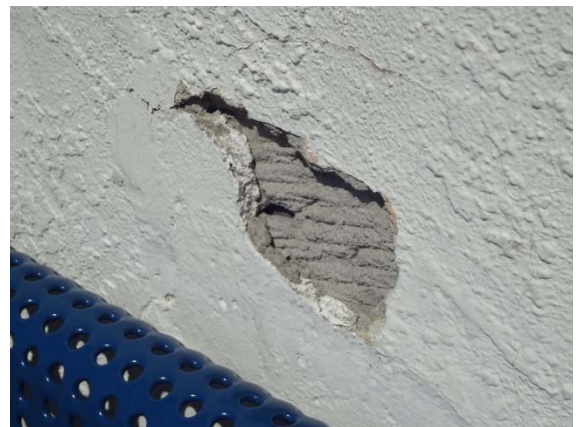
Photo #30: Damaged Stucco Finish at Portable Building

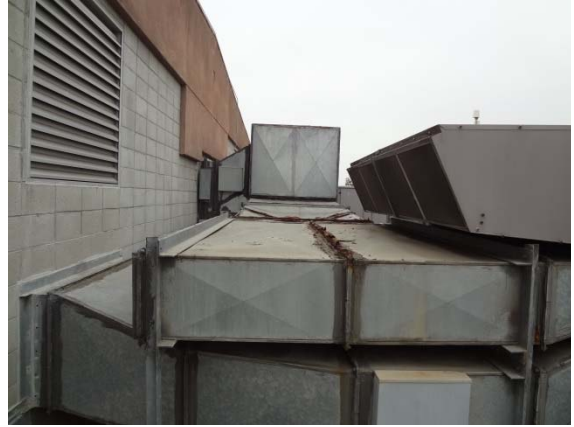
- Seal coating and stripping playgrounds.
- Seal coating and stripping parking lots.
- Duct replacement at Gym roof

Photo #50: Deteriorating Roof Ductwork at Gym

Location Name	Report Section	Location Description	ID	Cost Description	Quantity	Unit	Unit Cost	Subtotal	Deficiency Repair Estimate *
Marine View Middle	7.1	Gym roof	443242	Ductwork, Rooftop Mounted, Sheet Metal, 10 to 15' Diameter, Each Ton, Replace	4	EA	\$2,970.00	\$11,880	<b>\$11,880</b>
Marine View Middle	7.2	Gym Janitor Closet	439698	Interior Floor Finish, Carpet Standard-Commercial Medium-Traffic, Replace	1300	SF	\$7.26	\$9,433	<b>\$9,433</b>
Marine View Middle	8.1	Portable 30 Interior	439979	Interior Ceiling Finish, Acoustical Tile (ACT), Repair	16	SF	\$3.10	\$50	<b>\$50</b>
Marine View Middle	8.2	Library Bldg Concession	439883	Kitchen Counter, Plastic Laminate, Postformed, Replace	6	LF	\$43.90	\$263	<b>\$263</b>
<b>Immediate Repairs Total</b>									<b>\$21,626</b>
