# FACILITY CONDITION ASSESSMENT

FACILITY CONDITION ASSESSMENT  
OF  
MESA VIEW MIDDLE  
17601 AVILLA LANE  
HUNTINGTON BEACH, CALIFORNIA 92647

119317.16R000-008.017

May 12, 2016

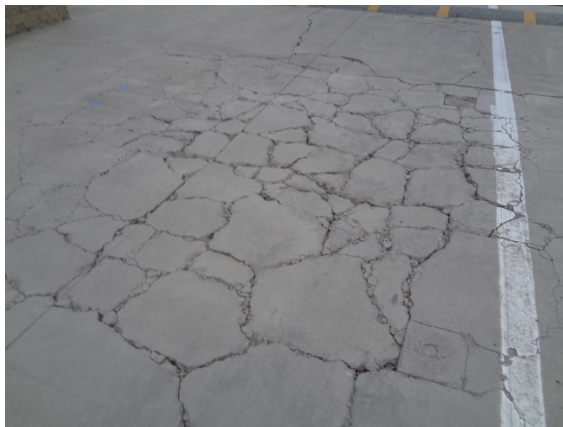
Photo #17: Cracking Section of Concrete Parking Lot

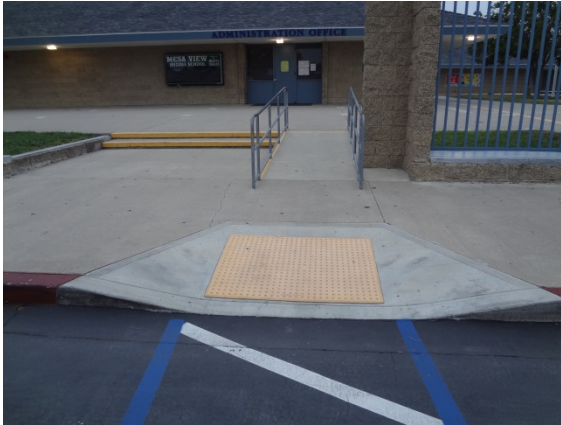
Photo #19: Depressed Curb

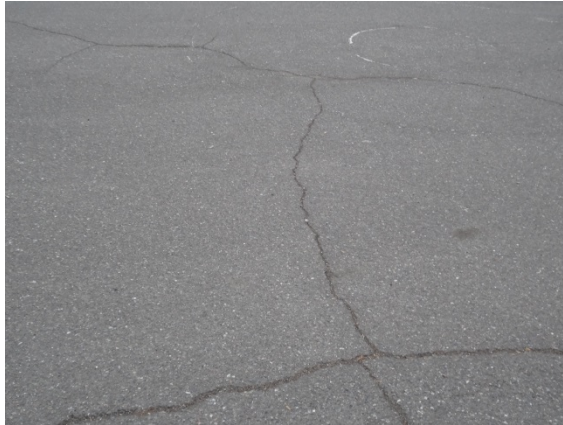
Photo #25: Minor Cracking Throughout Asphalt Playground

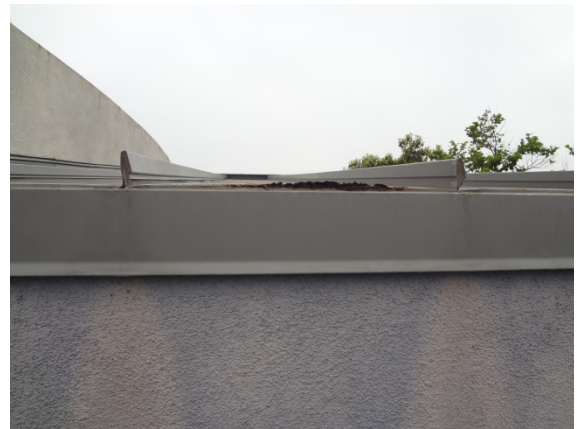
Photo #36: Gym Roof Corroding Edges
