# FACILITY CONDITION ASSESSMENT

FACILITY CONDITION ASSESSMENT  
OF  
OAK VIEW  
17241 OAK LANE  
HUNTINGTON BEACH, CALIFORNIA 92647

119317.16R000-009.017

May 29, 2016

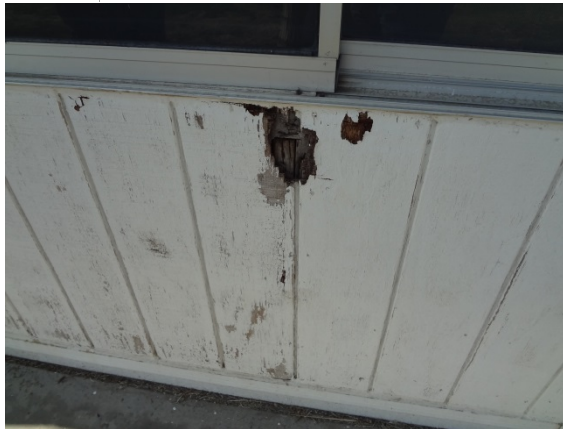
PHOTO #21: PORTABLE BUILDING DAMAGED WOOD SIDING

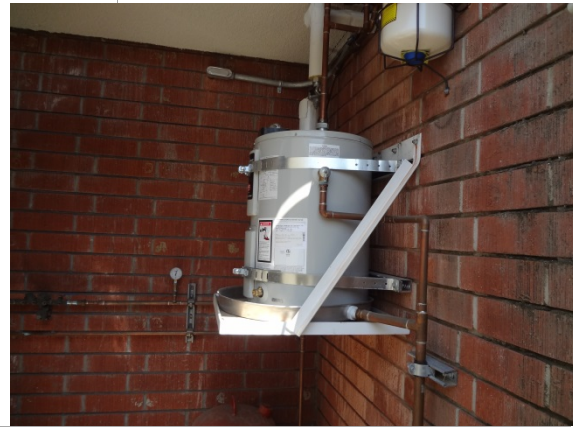
PHOTO #28: ELECTRIC WATER HEATER

7.2	438385	Water Heater, Electric, Residential, 16 to 29 GAL, Replace	1	EA	\$1,249.92	\$1,250		<b>\$1,250</b>
<b>Immediate Repairs Total</b>								<b>\$53,420</b>

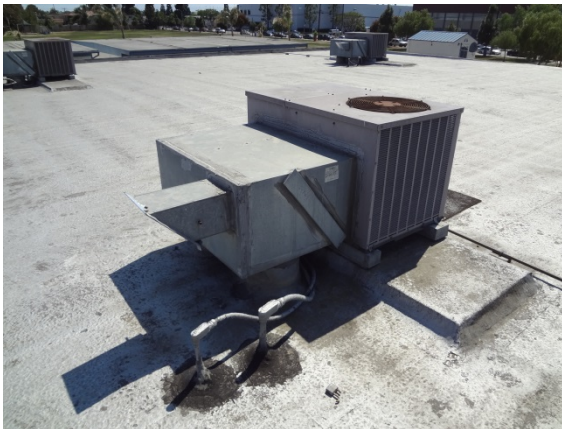
PHOTO #29: ROOFTOP HEAT PUMP

- Replace heat pumps on portable units.
- Replace rooftop units on Multipurpose Building and 4-Classroom Building.
- Replace heat pump and unit ventilators on Family Building.

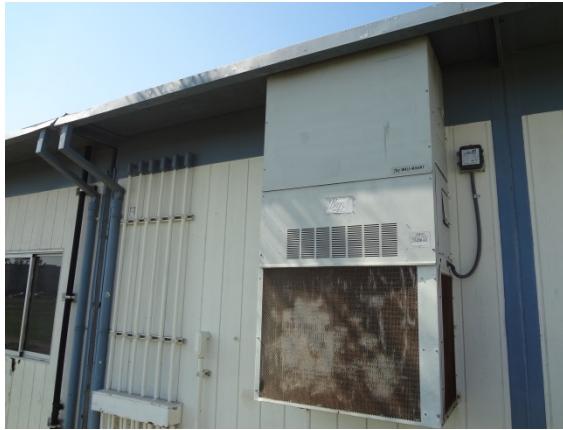
PHOTO #31: PORTABLE BUILDING HEAT PUMP
