FACILITY CONDITION ASSESSMENT

SUN VIEW ELEMENTARY
7721 JULIETTE LOW DRIVE
HUNTINGTON BEACH, CALIFORNIA 92647

EMG
10461 Mill Run Circle, Suite 1100
Owings Mills, Maryland 21117
800.733.0660
www.emgcorp.com

May 31, 2016

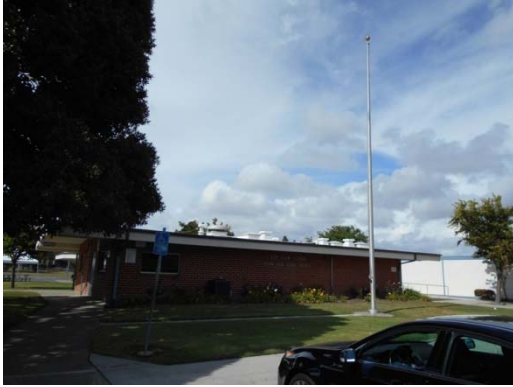
Photo #1: Front Elevation

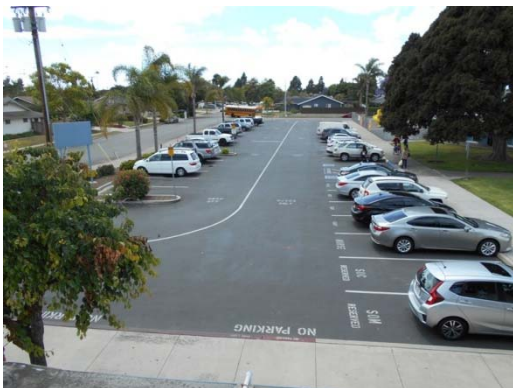
Photo #9: Parking Lot

5.2	Parking lot	435899	G2022 Asphalt Pavement, Parking Lot, Seal & Stripe	5	2	* 3	29000	SF	\$0.38	\$11,006				\$11,006					\$11,006						\$11,006						\$11,006	\$44,022

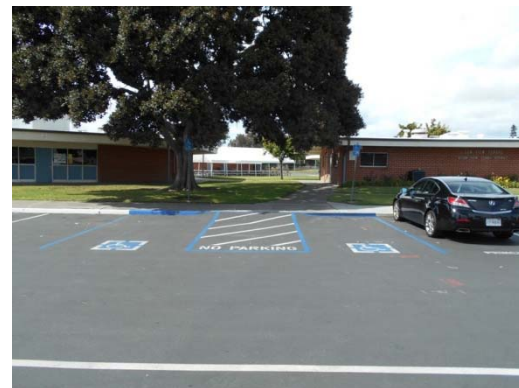
Photo #10: Accessible Parking Stalls

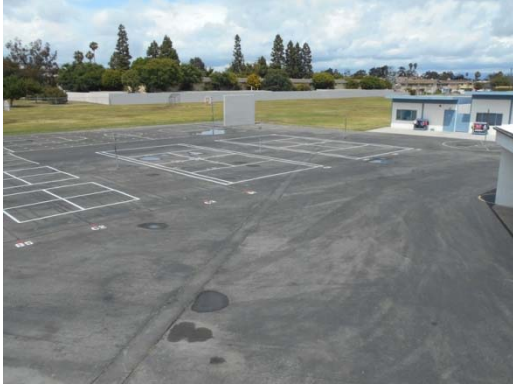
Photo #13: Basketball Courts

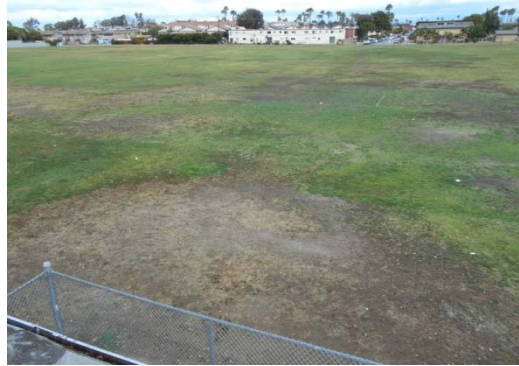
Photo #14: Grass Field with Barren Areas

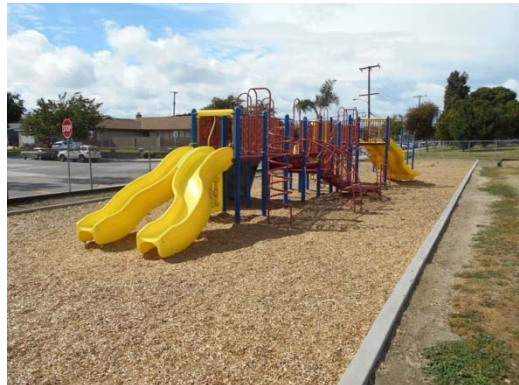
Photo #16: Playground Equipment

5.5	Playgrounds	435894	G2047 Play Structure, Medium, Replace	20	10	* 10	2	EA	\$40,005.63	\$80,011											\$80,011											\$80,011								
6.3	Portable Buildings	435873	B3011 Roof, Built-Up, Replace	20	16	* 4	8790	SF	\$12.96	\$113,931					\$113,931																	\$113,931

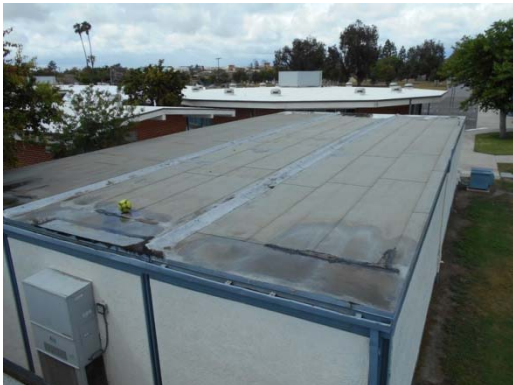
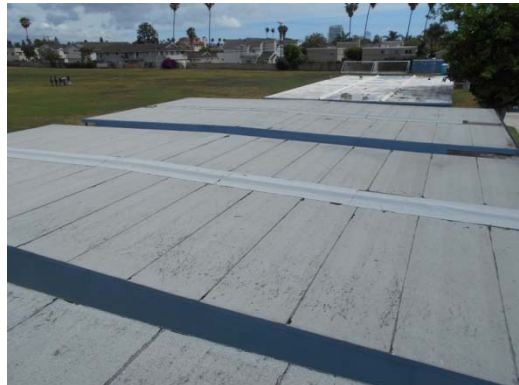
Photo #21: Portable Building Built-up Roof

Photo #22: Portable Building Built-up Roof

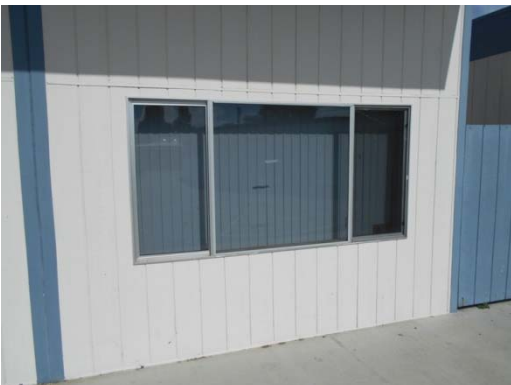
Photo #29: Aluminum Windows

6.6	Through out main buildings including pods, office and kitchen	435887	B2021 Window, Aluminum Double-Glazed 12 SF, 1-2 Stories, Replace	30	27	3	22	EA	\$584.21	\$12,853				\$12,853																		\$12,853

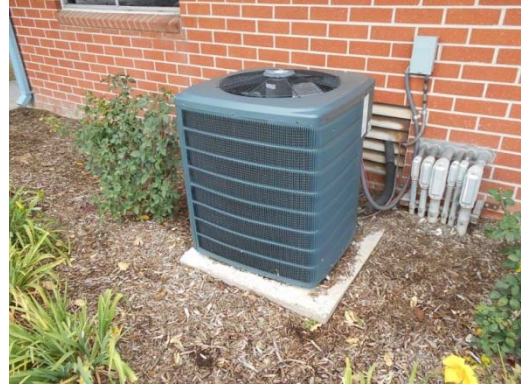
Photo #32: Condensing Unit at Office Building

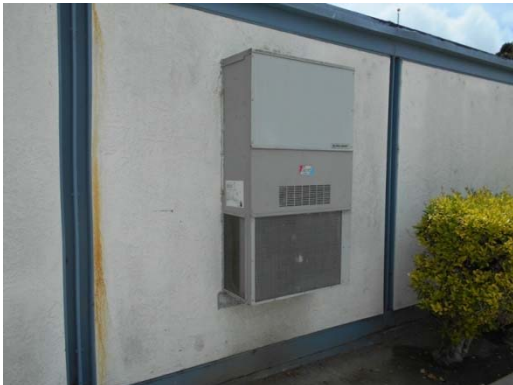
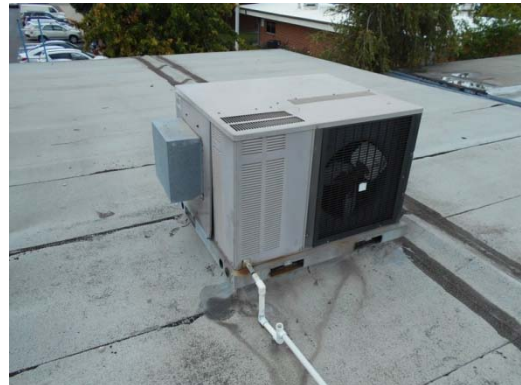
Photo #33: Heat Pump Unit at Portable Building

Photo #34: Heat Pump Unit at Portable Building

7.1	Walls and roofs of portable buildings	435875	D3052 Heat Pump, 3.5 to 5 Ton, Replace	15	10	5	7	EA	\$8,928.22	\$62,498					\$62,498																	\$62,498

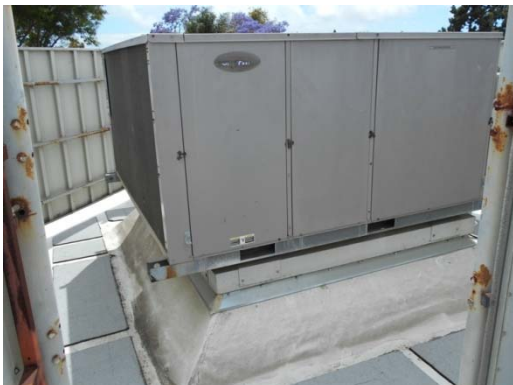
Photo #35: Heat Pump Package Unit at Classroom Pod

7.1	Rooftop of classroom pods	435990	D3052 Heat Pump, 16 to 20 Ton, Replace	15	13	* 2	3	EA	\$39,982.39	\$119,947				\$119,947																		\$119,947

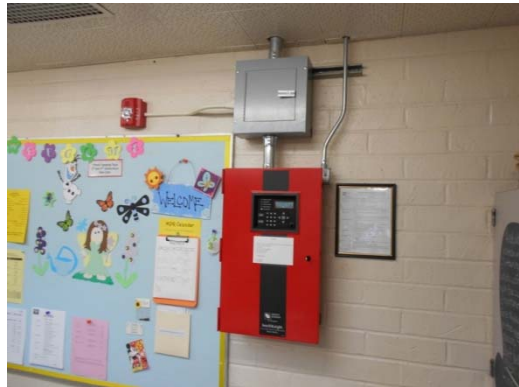
Photo #40: Central Fire Control Panel in Main Office

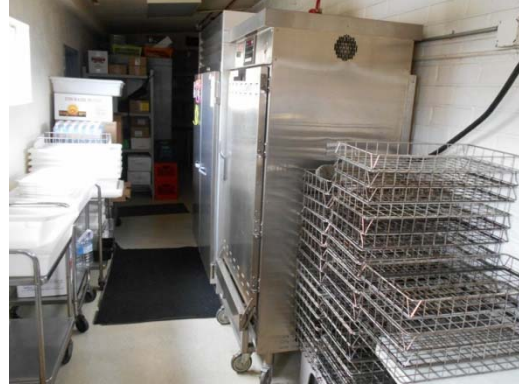
Photo #44: Reach-in Refrigerator

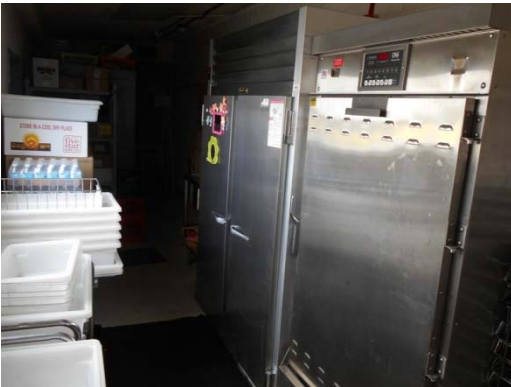
Photo #45: Food Warmer

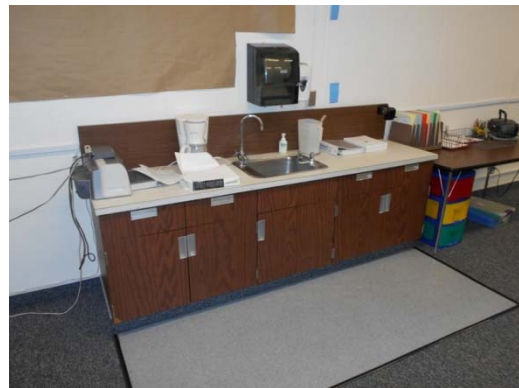
Photo #48: Casework in Teacher's Lounge

3.1	Classrooms and offices	438131	Z103X ADA, Kitchen, Cabinetry, Modify	0	0	* 0	320	LF	\$126.50	\$40,480	\$40,480																				\$40,480									
3.1	In front of main entrance	435902	Z106X ADA, Parking, Designated Stall with Pavement Markings & Signage, Install	0	0	* 0	1	EA	\$1,265.00	\$1,265	\$1,265																				\$1,265

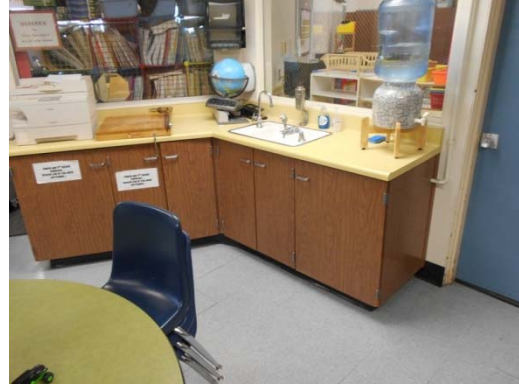
Photo #50: Casework in Classroom
