FACILITY CONDITION ASSESSMENT

FACILITY CONDITION ASSESSMENT
OF
VISTA VIEW MIDDLE
16250 HICKORY STREET
FOUNTAIN VALLEY, CALIFORNIA 92708

119317.16R000-016.017

June 8, 2016

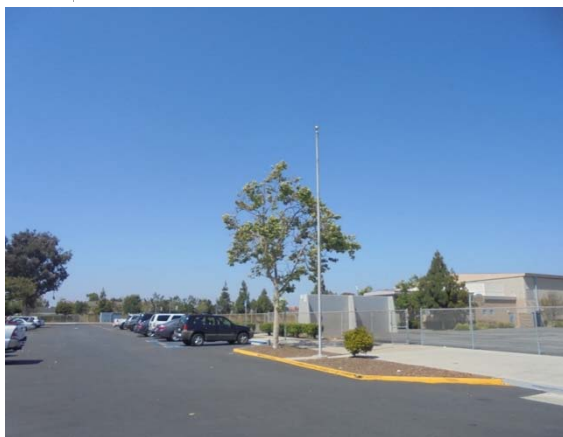
Photo #11: Front Parking Lot

5.2	Front parking lot		440204	G2012 Asphalt Pavement, Roadways, Seal & Stripe	5	2	* 3	26000	SF	\$0.38	\$9,867					\$9,867																	\$9,867	\$39,468

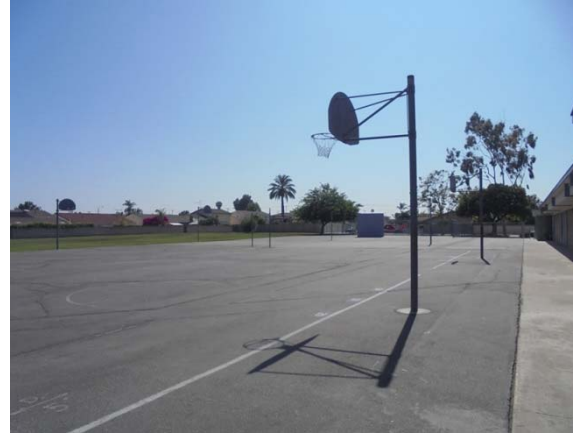
Photo #14: Basketball Courts

5.5	Playing courts		440201	G2047 Basketball/Tennis/Play Court, Asphalt, Seal & Stripe	5	2	* 3	10000	SF	\$0.38	\$3,805					\$3,805																		\$3,805	\$15,220

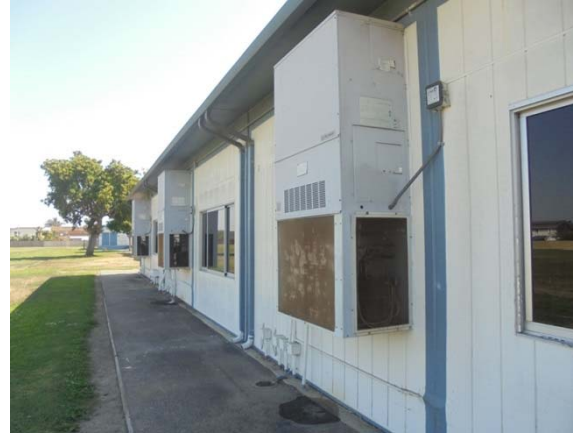
Photo #26: Heat Pumps at Portable Classrooms

7.1	Portable Classroom		443666	D3032 Condensing Unit/Heat Pump, Split System, 3.5 Ton, Replace	15	10	* 5	6	EA	\$4,129.27	\$24,776							\$24,776																	\$24,776

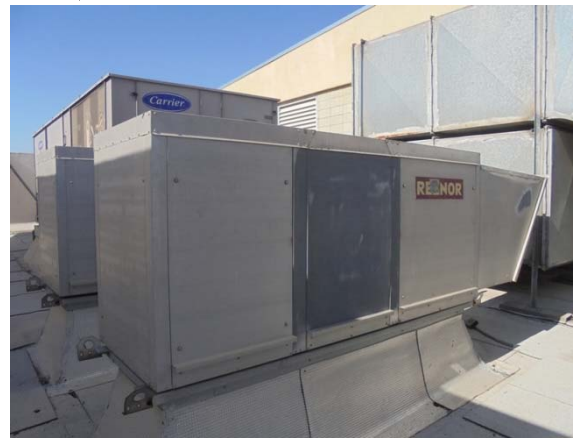
Photo #28: Heating Unit for Locker Room

7.1	Gym Roof - Locker Rooms		443646	D3051 Unit Heater, Natural Gas, 26 to 55 MBH, Replace	20	14	* 6	2	EA	\$4,281.60	\$8,563											\$8,563													\$8,563

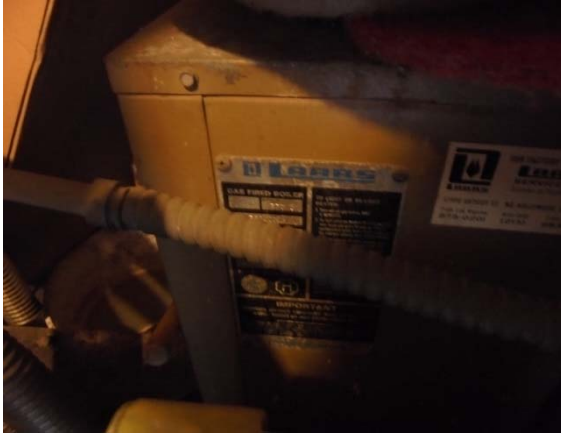
Photo #31: Abandoned Boiler at Main Building

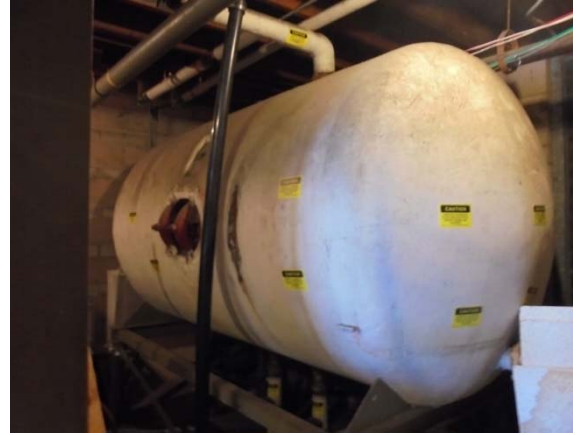
Photo #32: Abandoned Water Storage Tank

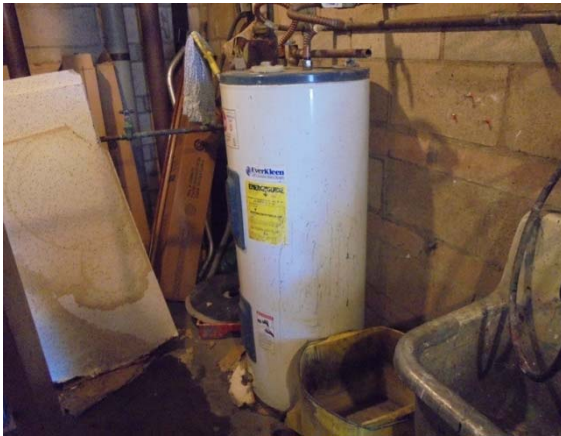
Photo #33: Water Heater at Main Building

7.2	Main building		440237	D2023 Water Heater, Gas, Commercial, 60 to 120 GAL., Replace	15	2	* 13	1	EA	\$10,698.82	\$10,699																\$10,699							\$10,699	\$10,699

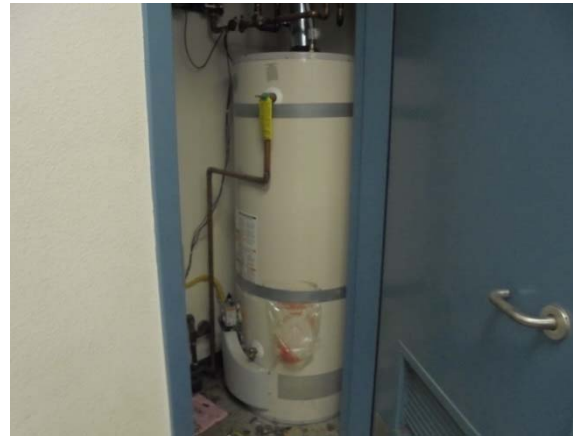
Photo #34: Water Heater at Gymnasium

7.2	Gymnasium		440242	D2023 Water Heater, Gas, Commercial, 60 to 120 GAL., Replace	15	4	11	1	EA	\$10,698.82	\$10,699												\$10,699												\$10,699	\$10,699

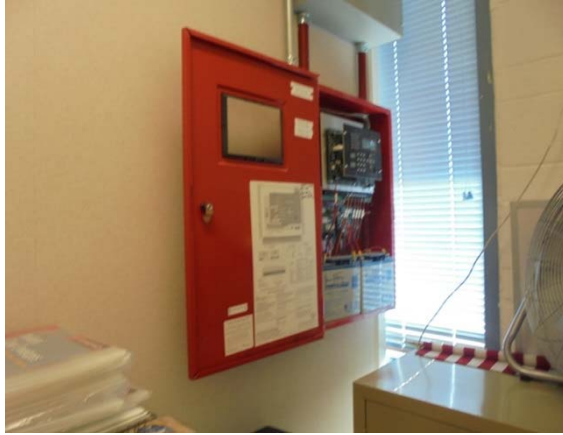
Photo #37: Fire Alarm Panel at Main Building

7.6	Main office		440244	D5037 Fire Alarm Control Panel, Addressable, Replace	15	2	* 13	1	EA	\$20,297.59	\$20,298																\$20,298								\$20,298	\$20,298
