# FACILITY CONDITION ASSESSMENT

FACILITY CONDITION ASSESSMENT  
OF

WESTMONT ELEMENTARY  
8251 HEIL AVENUE  
WESTMINSTER, CALIFORNIA 92683

June 3, 2016

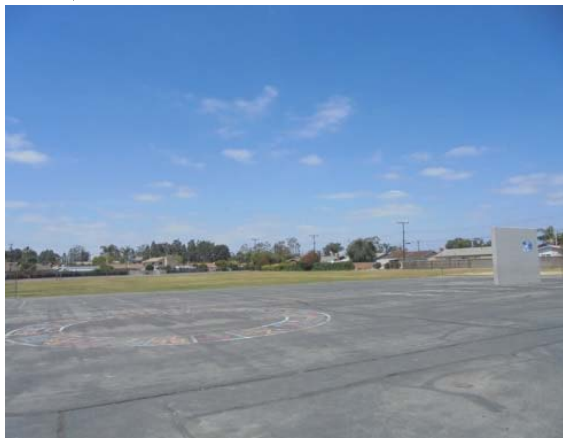
Photo #15: Rear yard play surfaces

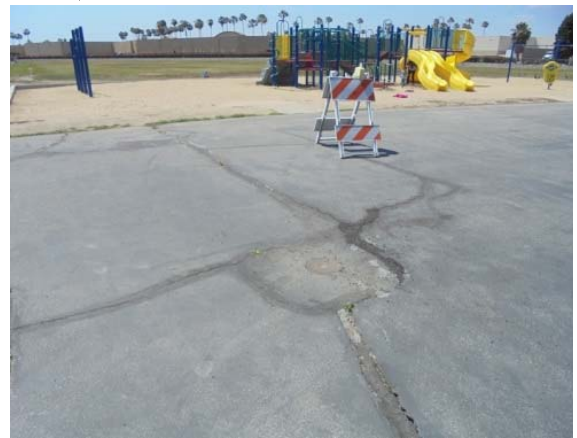
Photo #16: Damaged rear yard play surfaces

Location Name	Report Section	Location Description	ID	Cost Description	Quantity	Unit	Unit Cost	Subtotal	Deficiency Repair Estimate *
Westmont Elementary	5.5	Play surface	437915	Asphalt Pavement, Roadways, Seal & Stripe	10000	SF	\$0.38	\$3,795	<b>\$3,795</b>
<b>Immediate Repairs Total</b>									<b>\$3,795</b>
