# FACILITY CONDITION ASSESSMENT

FACILITY CONDITION ASSESSMENT  
OF  
SPRING VIEW MIDDLE  
16662 TRUDY LANE  
HUNTINGTON BEACH, CALIFORNIA 92647

**Immediate Repairs Report**  
**Spring View Middle**  
**6/7/2016**

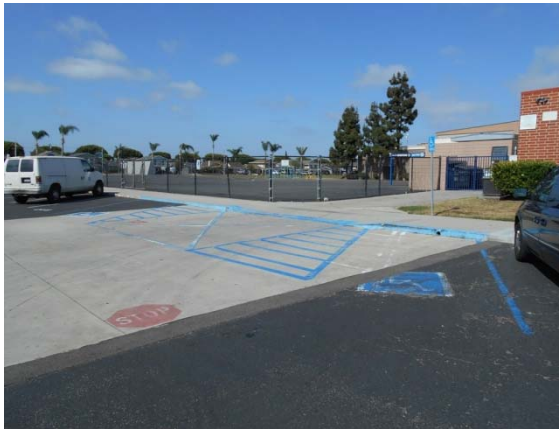
Photo #9: Accessible Stalls

3.1	Close to main entrance	439480	ADA, Parking, Designated Stall with Pavement Markings & Signage (Van), Install	1	EA	\$1,391.50	\$1,392	<b>\$1,392</b>

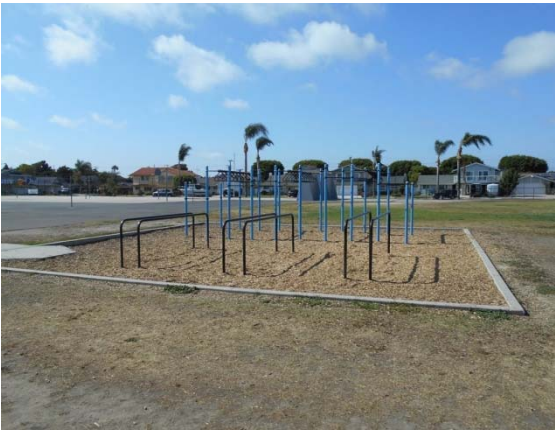
Photo #15: Playground Equipment

5.5	Playgrounds	439005	G2047 Play Structure, Medium, Replace	20	10	10	2	EA		\$5,000.00	\$10,000										\$10,000											\$10,000
5.2 and 5.5	North and south play courts	439020	G2047 Basketball/Tennis/Play Court, Asphalt, Seal & Stripe	5	2	3	85190	SF		\$0.38	\$32,415				\$32,415					\$32,415					\$32,415					\$32,415		\$129,659

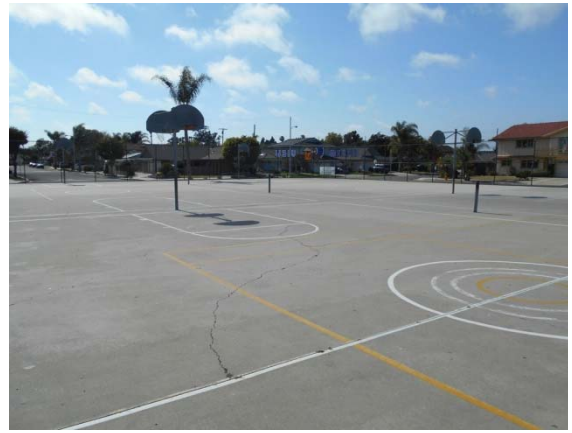
Photo #16: Concrete Basketball Court

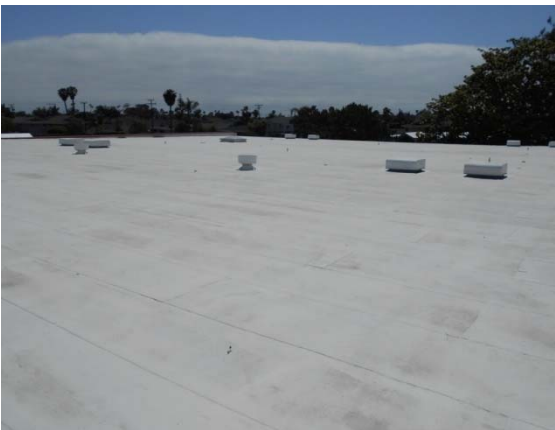
Photo #17: Main Classroom Building Built-up Roof

6.3	Main Building Roofs	439001	B3011 Roof, Built-Up, Replace	20	1	19	59950	SF		\$12.96	\$777,036																				\$777,036	\$777,036
6.4	Throughout the buildings	439004	B2011 Exterior Wall, Painted Surface, 1-2 Stories, Prep & Paint	10	5	5	14500	SF		\$2.87	\$41,625						\$41,625									\$41,625						\$83,250

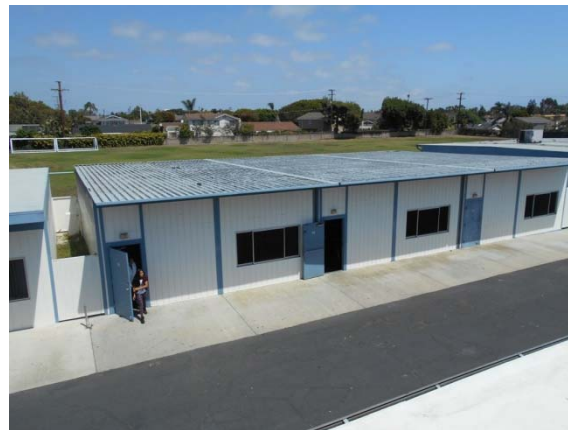
Photo #18: Steel Roof Over Portable Buildings

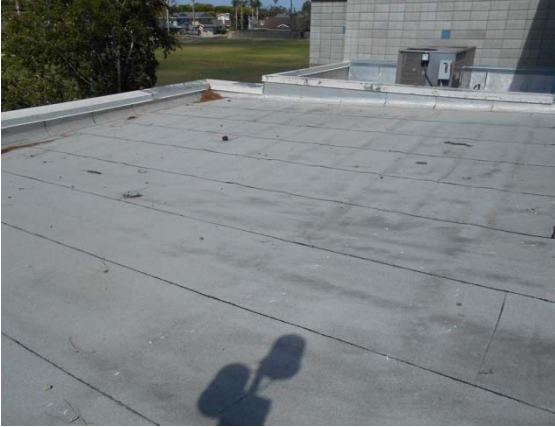
Photo #19: Buildup Roof at Gymnasium Building

6.3	Lower gymnasium building roof and Some Portable Buildings	439025	B3011 Roof, Built-Up, Replace	20	19	1	12330	SF		\$12.96	\$159,814		\$159,814																			\$159,814

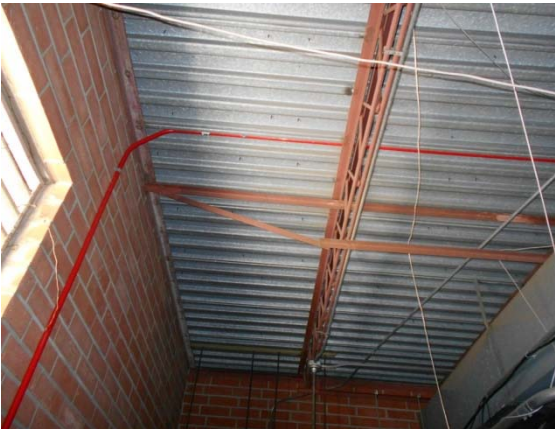
Photo #21: Roof Structure

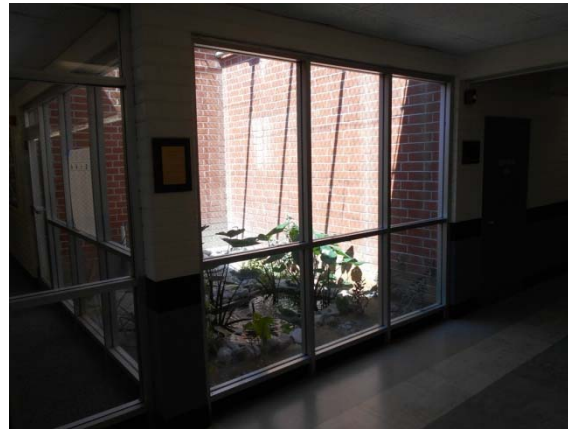
Photo #22: Storefront Windows

6.6	Throughout the main 1965 buildings	438999	B2023 Storefront, MetaI-Framed Windows w/out Door(s), Replace	30	29	1	1200	SF		\$48.00	\$57,600		\$57,600																			\$57,600

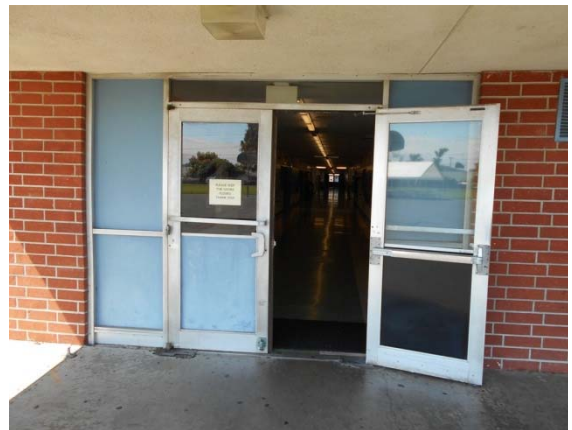
Photo #24: Storefront Window with Door

6.6	Throughout main building	439000	B2023 Storefront, MetaI-Framed 3' x 7' Swinging Door Only, Replace	30	28	2	10	EA		\$2,106.57	\$21,066			\$21,066																		\$21,066

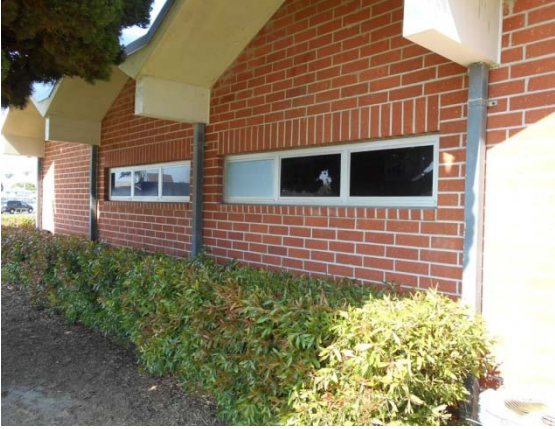
Photo #25: Aluminum Window

6.6	Through out main 1965 buildings	439022	B2021 Window, Aluminum Double-Glazed 12 SF, 1-2 Stories, Replace	30	29	1	15	EA		\$584.21	\$8,763		\$8,763																			\$8,763

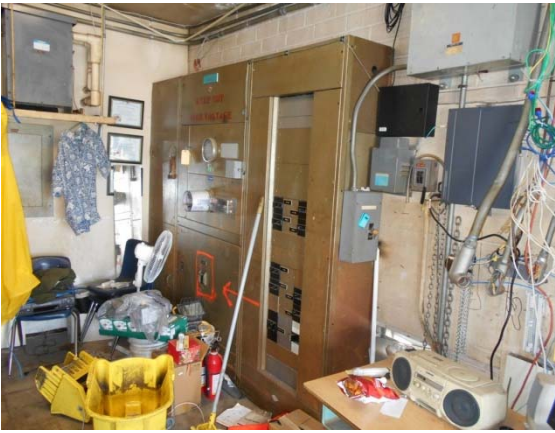
Photo #27: Main Electric Switchgear

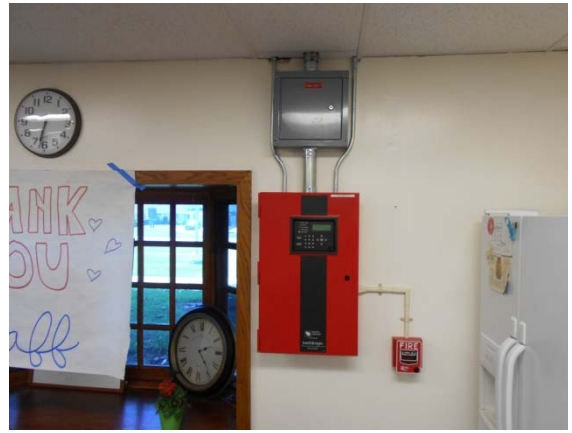
Photo #28: Central Fire Alarm Panel

7.6	Main office	439023	D5037 Fire Alarm Control Panel, Multiplex, Replace	15	1	14	1	EA		\$4,284.35	\$4,284															\$4,284						\$4,284
8.1	Throughout the buildings	439009	C3012 Interior Wall Finish, Gypsum Board/Plaster/Metal, Prep & Paint	8	4	4	151550	SF		\$1.42	\$215,686				\$215,686						\$215,686											\$431,372

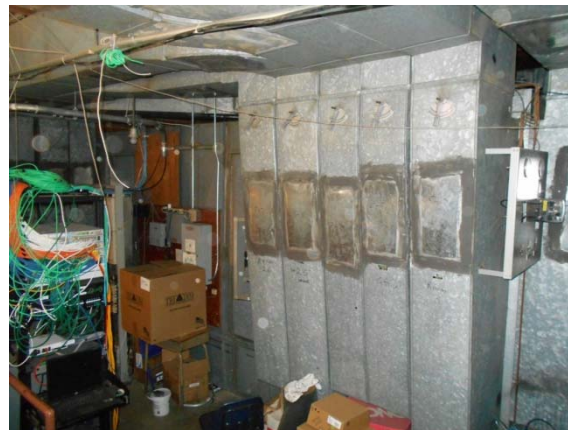
Photo #30: Interior Air Handling Units

7.1	Main classroom building panthouse	439514	D3041 Air Handler, Interior, 10,001 to 15,000 CFM, Replace	30	29	1	3	EA		\$41,979.17	\$125,938		\$125,938																			\$125,938

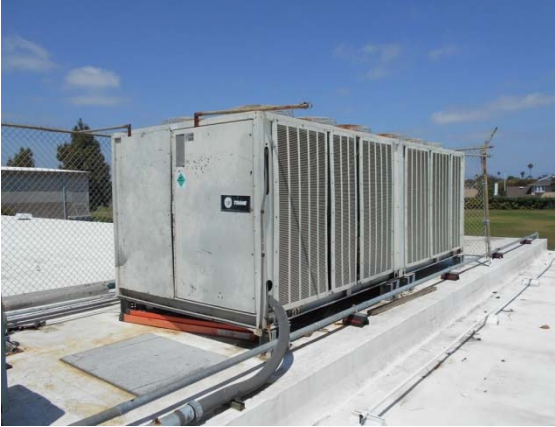
Photo #31: Chiller

7.1	Boiler and chiller	438998	D2023 Circulator Pump, 3 HP, Replace	15	3	12	2	EA		\$8,839.12	\$17,678										\$17,678											\$17,678
7.1	Rooftop of main classroom building	439513	D3031 Chiller, Air-Cooled, 101 to 150 Ton, Replace	25	20	5	1	EA		\$180,236.86	\$180,237					\$180,237																\$180,237

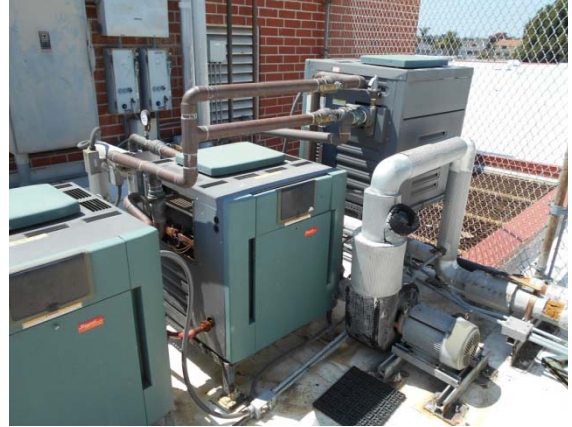
Photo #32: Boilers

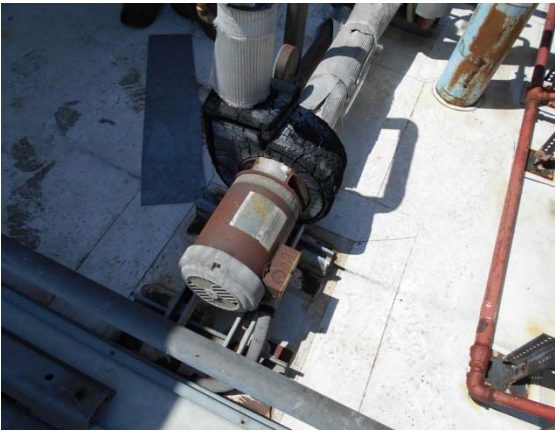
Photo #33: Water Circulating Pump

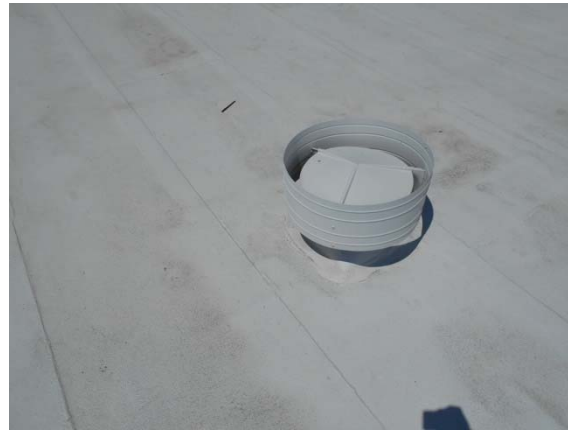
Photo #34: Roof Exhaust Fan

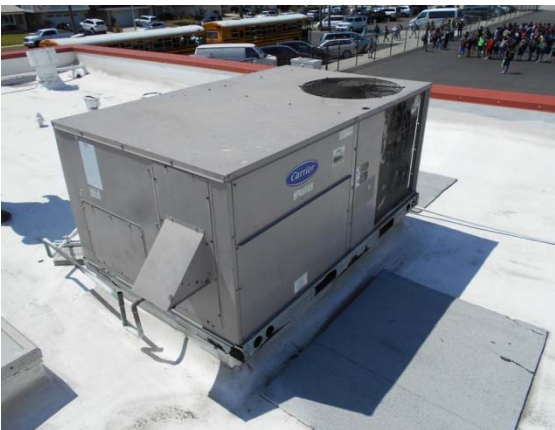
Photo #35: Rooftop Packaged Unit

7.1	Roof top of multi-purpose building serving office	439528	D3052 Package Unit, 4 Ton, Replace	15	12	* 3	1	EA		\$10,581.39	\$10,581			\$10,581														\$10,581				\$21,163

7.1	Gym roof serving gym stage	439530	D3052 Package Unit, 6 to 7.5 Ton, Replace	15	12	3	1	EA		\$14,395.83	\$14,396				\$14,396															\$14,396		\$28,792

7.1	Gym roof serving classroom	439534	D3052 Package Unit, 4 Ton, Replace	15	12	3	1	EA		\$10,581.39	\$10,581				\$10,581															\$10,581		\$21,163

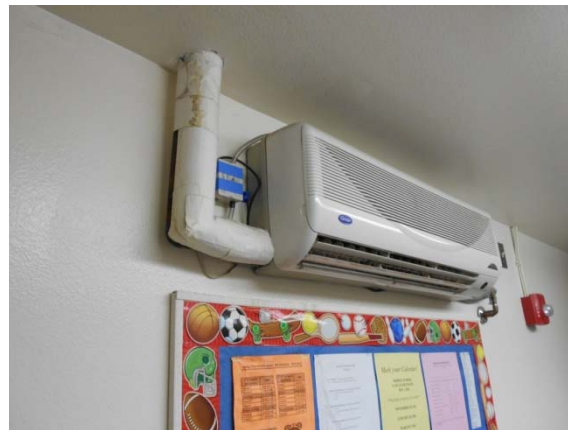
Photo #36: Ductless Split Air Conditioning Unit

7.1	Gym coaches offices	439533	D3032 Ductless Split System, Single Zone, 0.75 to 1 Ton, Replace	15	12	3	2	EA		\$3,221.22	\$6,442				\$6,442															\$6,442		\$12,885

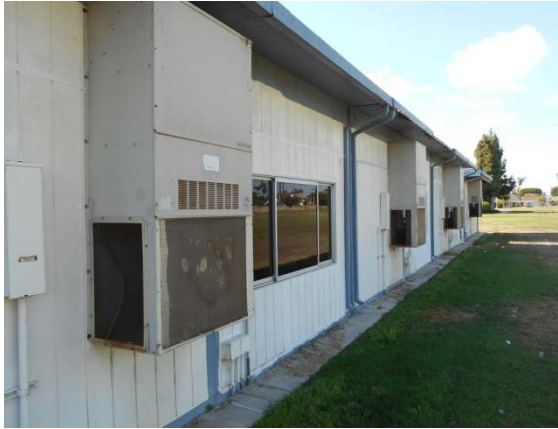
Photo #37: Wall Mounted Heat Pump

7.1	Wall and rooftop of portable buildings	439012	D3052 Heat Pump, 3.5 to 5 Ton, Replace	15	14	1	6	EA		\$8,928.22	\$53,569		\$53,569														\$53,569					\$107,139

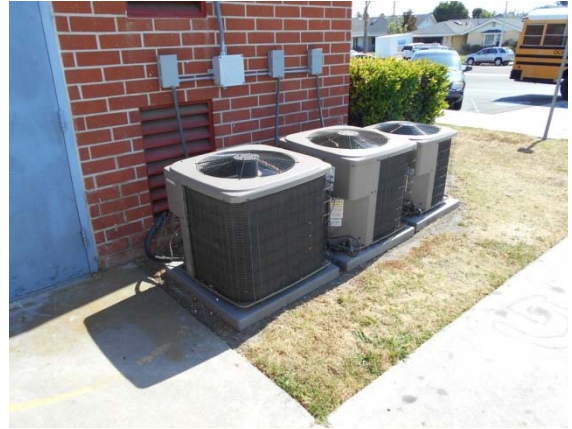
Photo #38: Condensing Units

7.1	Exterior next to the Library and computer lab	439527	D3032 Condenser, Air-Cooled, 5 Ton, Replace	15	14	1	2	EA		\$4,237.42	\$8,475		\$8,475														\$8,475					\$16,950

7.1	Exterior next to Multi-purpose room	439521	D3032 Condenser, Air-Cooled, 5 Ton, Replace	15	2	13	3	EA		\$4,237.42	\$12,712										\$12,712											\$12,712

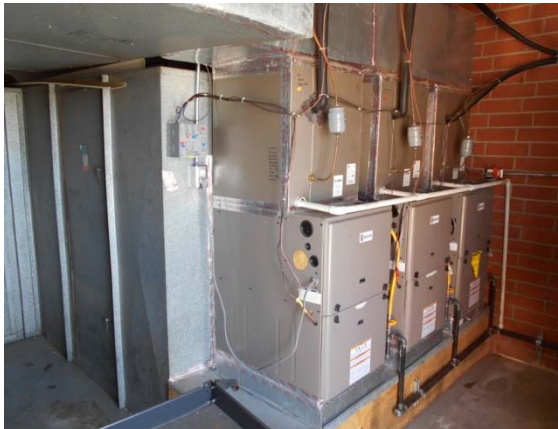
Photo #39: Furnace

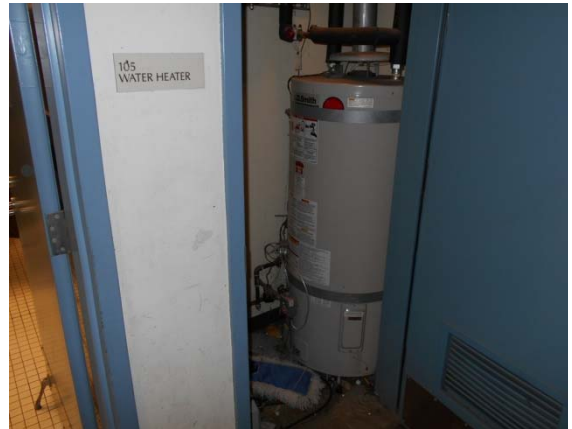
Photo #40: Domestic Water Heater

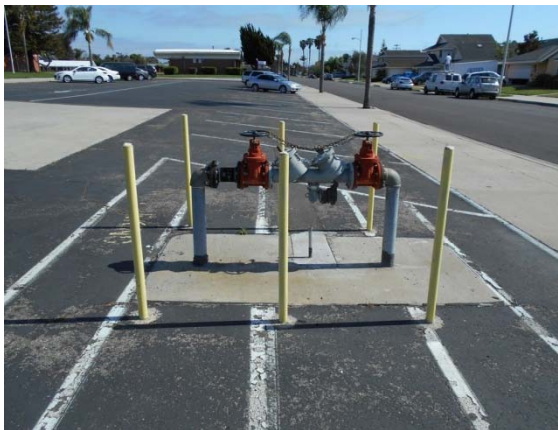
Photo #41: Backflow Preventer

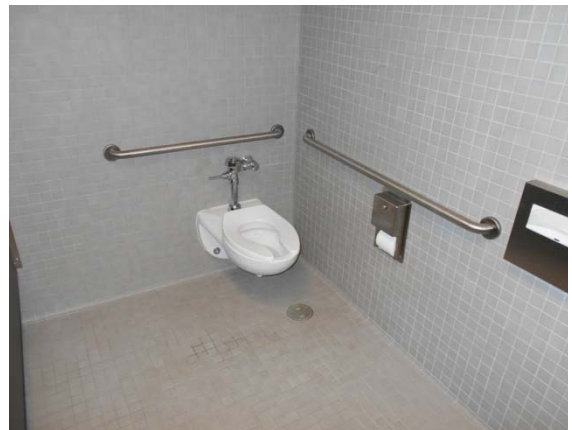
Photo #42: Accessible Stall

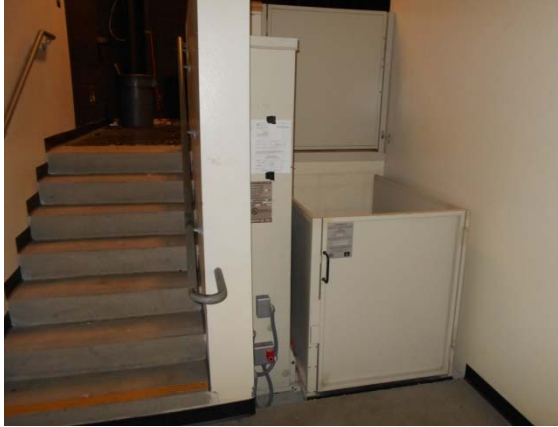
Photo #49: Gym Stage Wheelchair Lift

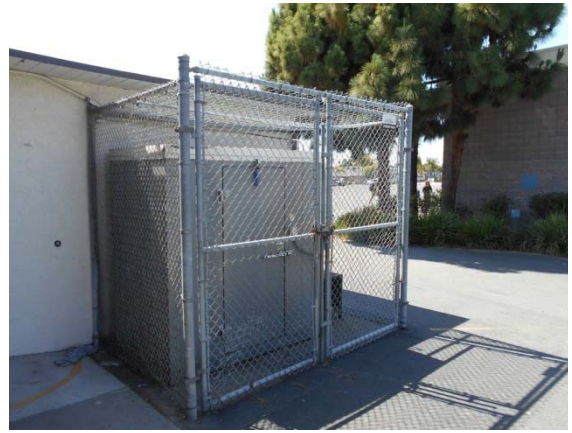
Photo #52: Walk-in Freezer

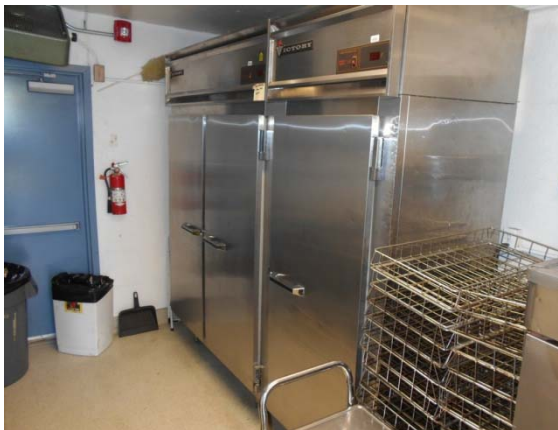
Photo #53: Reach-in Refrigerator

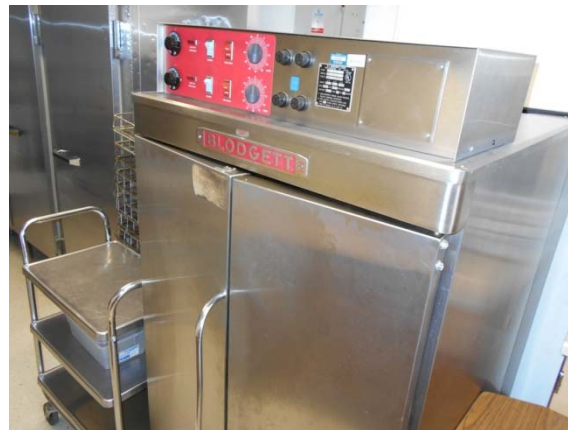
Photo #54: Food Warmer
